# Overview of the Full Scale Durability Tests on F-35 Lightning II Program

**Marguerite E. Christian**  
**Senior Manager**  
**Structures Test**  
*F-35 Structures Development*  
*Lockheed Martin Aeronautics Company*

*2012 Aircraft Structural Integrity Program (ASIP) Conference*  
*November 27-29, 2012*  
*San Antonio, TX*

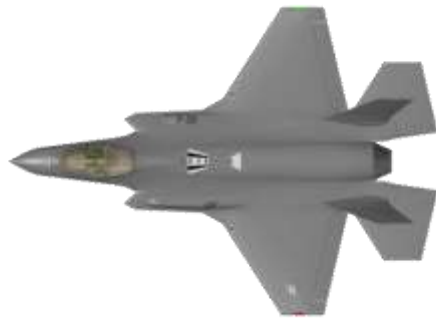
**F-35A CTOL**

Span ..... 35 ft / 10.67 m  
 Length ..... 51.4 ft / 15.67 m  
 Wing area ..... 460 ft<sup>2</sup> / 42.7 m<sup>2</sup>  
 Combat radius (internal fuel) >590 n.mi / 1,093 km  
 Range (internal fuel) ..... ~1,200 n.mi / 2,222 km

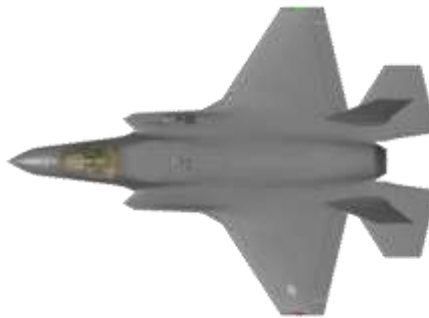
**F-35B STOVL**

Span ..... 35 ft / 10.67 m  
 Length ..... 51.2 ft / 15.61 m  
 Wing area ..... 460 ft<sup>2</sup> / 42.7 m<sup>2</sup>  
 Combat radius (internal fuel) >450 n.mi / 833 km  
 Range (internal fuel) ..... ~900 n.mi / 1,667 km

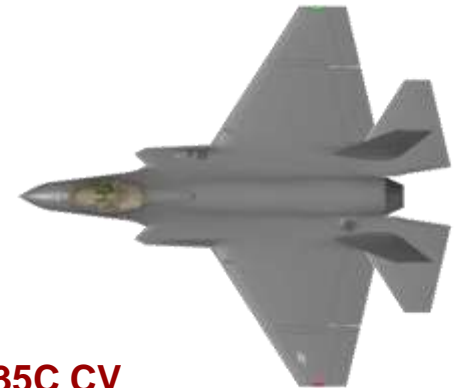
**F-35C CV**

Span ..... 43 ft / 13.11 m  
 Length ..... 51.4 ft / 15.67 m  
 Wing area ..... 668 ft<sup>2</sup> / 62.06 m<sup>2</sup>  
 Combat radius (internal fuel) >600 n.mi / 1,111 km  
 Range (internal fuel) ..... >1,200 n.mi / 2,222 km

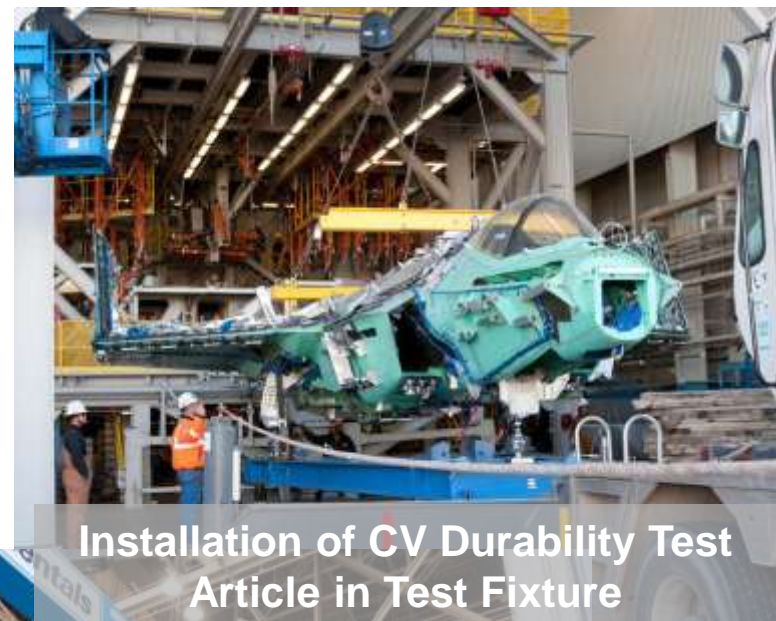
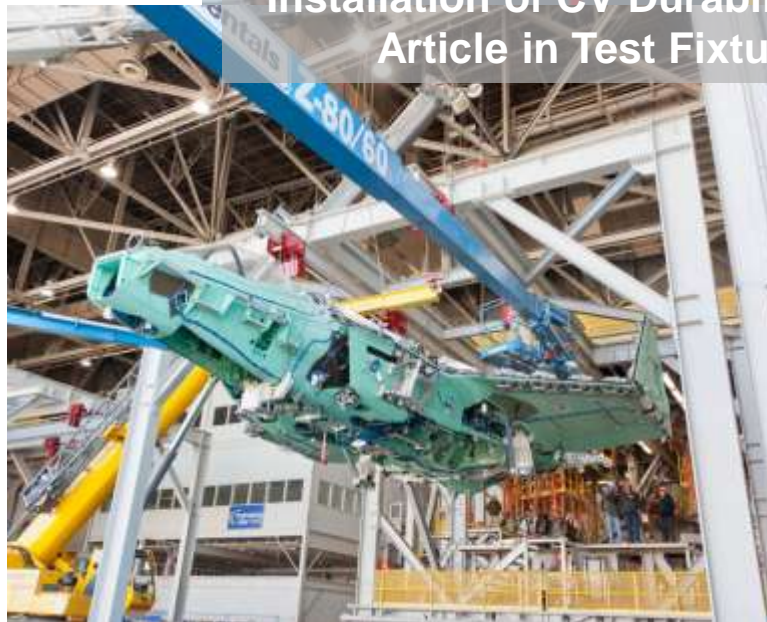
- **Durability Test Program Builds Upon Static Test**
  - *Using Same Fixture*
  - *Same Load Control and Data Acquisition Systems*
  - *Minor Differences in Load Arrangement*
- **Some Differences Between Static and Durability Tests**
  - *Leading Edge Flaps Move Under Load*
  - *LH and RH “Dummy” Vertical Tails*
  - *Vertical Tails Tested As Separate Components*

**Use of Common Test Fixture Reduced Program Cost**

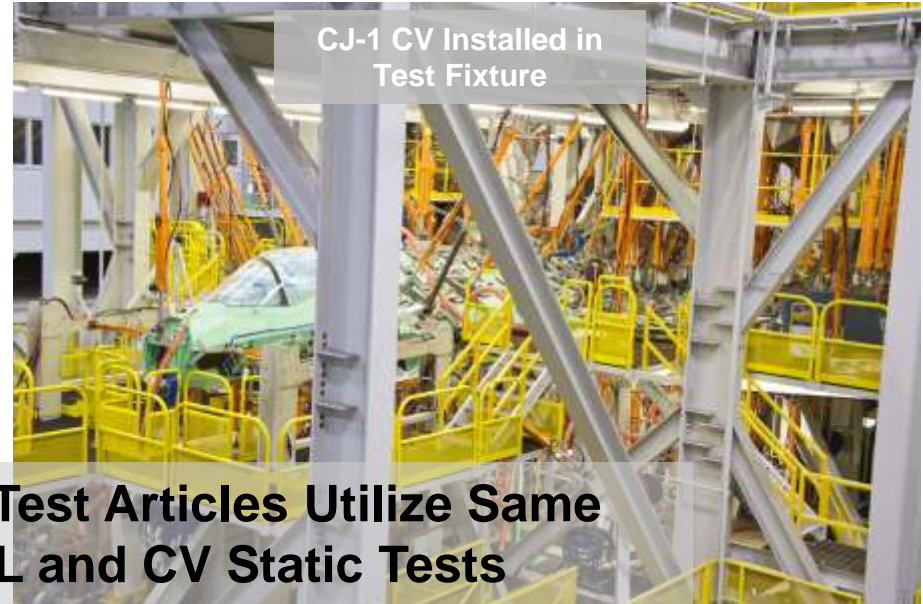
CJ-1 CV Installed in Test Fixture

**STOVL and CV Durability Test Articles Utilize Same Fixture Used for STOVL and CV Static Tests**

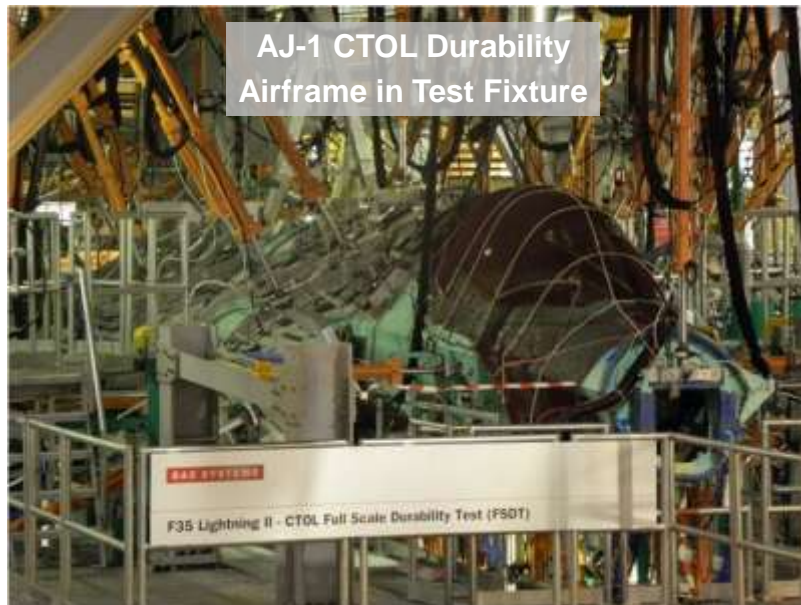
AJ-1 CTOL Durability Airframe in Test Fixture

- **Dedicated Test Fixture for CTOL Durability Test Article**
  - Enabled Test to Start Upon Delivery of Test Article

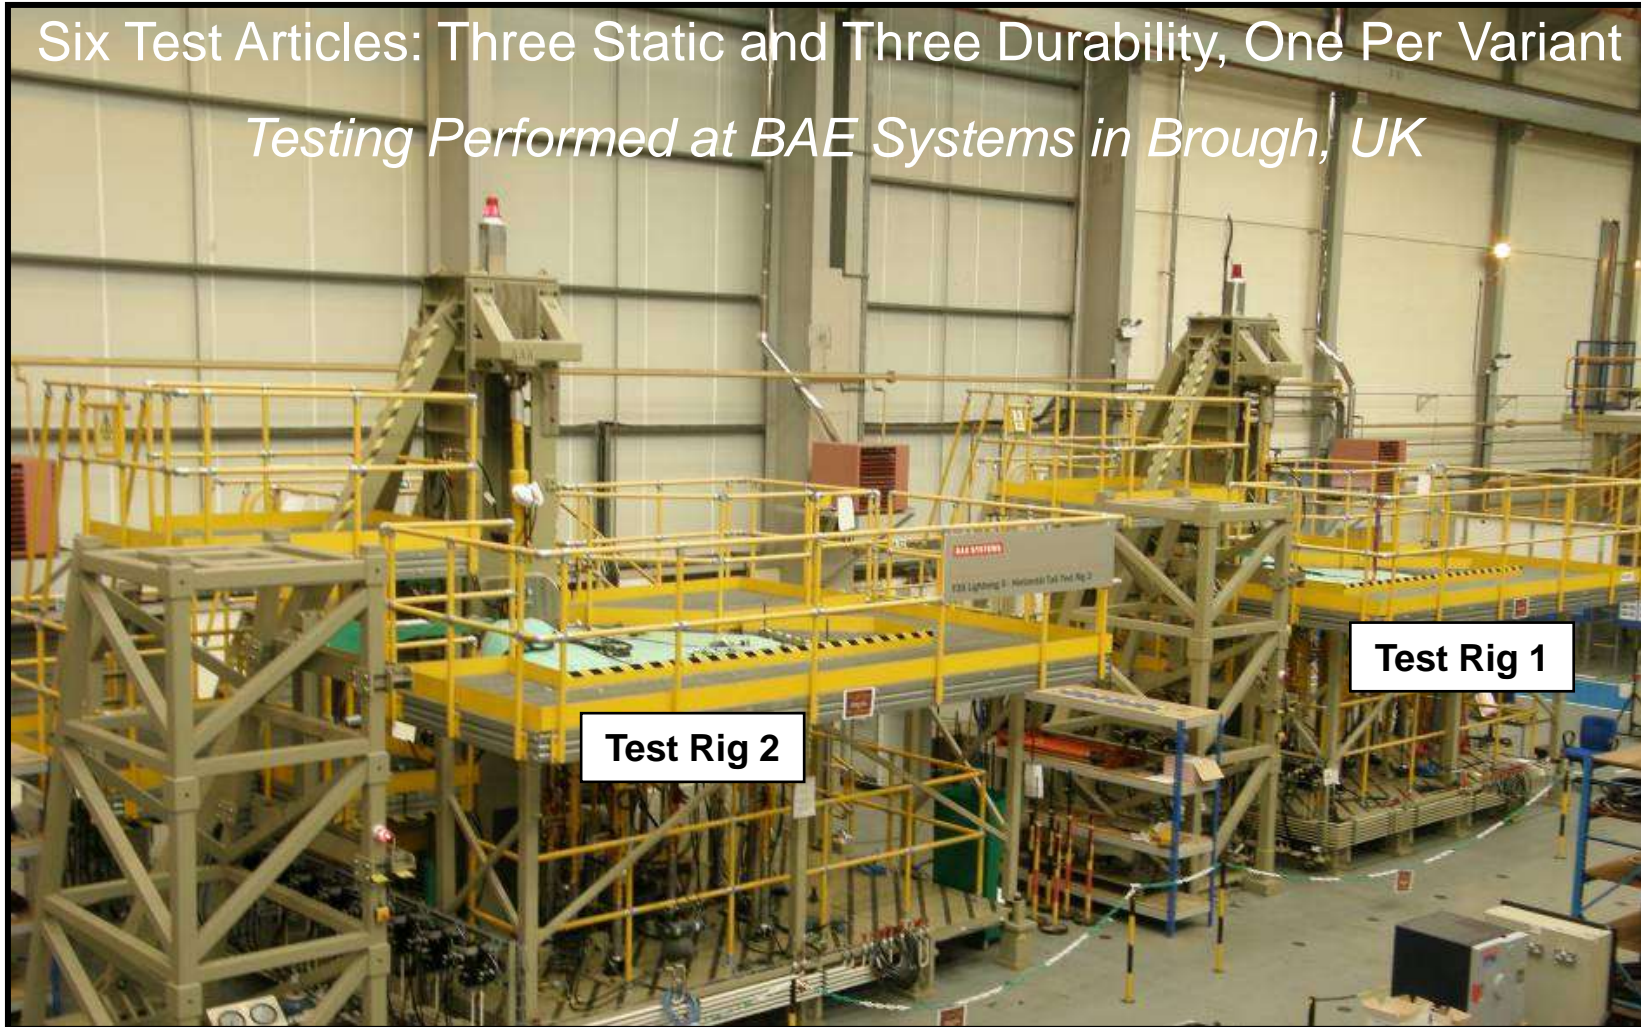
Six Test Articles: Three Static and Three Durability, One Per Variant  
*Testing Performed at BAE Systems in Brough, UK*

**Two Common Rig Designs - Interchangeable for Each Aircraft Variant for Both Static and Durability Tests**

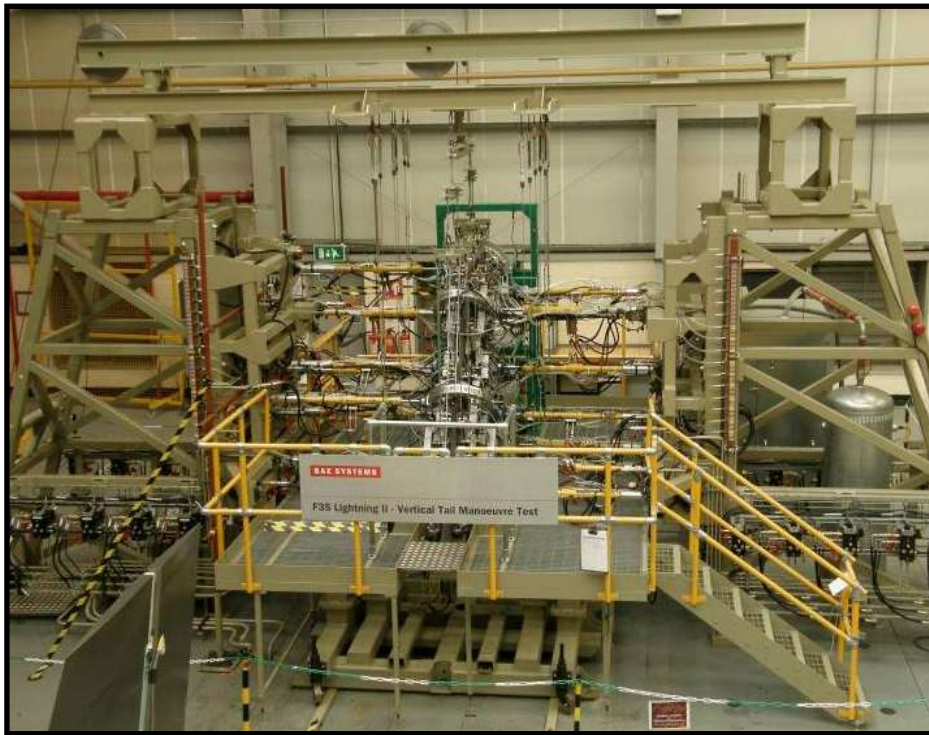
## Three VT Durability Test Articles, One Per Variant Performed at BAES in Brough, UK

- One Manoeuvre Test Rig
- Built to Accommodate All Three Variants

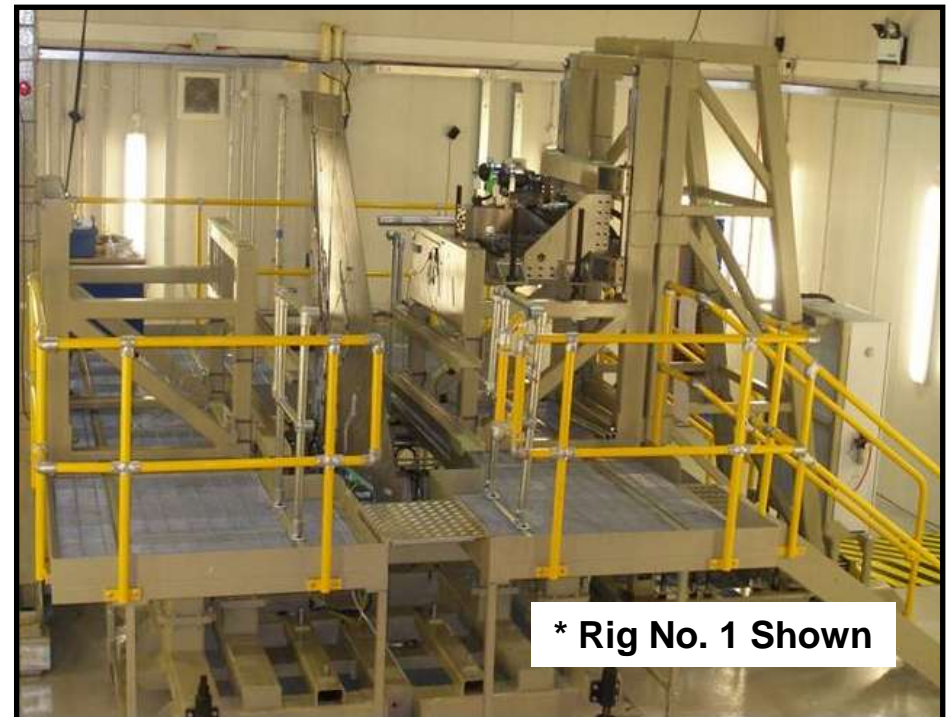
- Two Buffet/Vibration Test Rigs
- Built to Accommodate All Three Variants

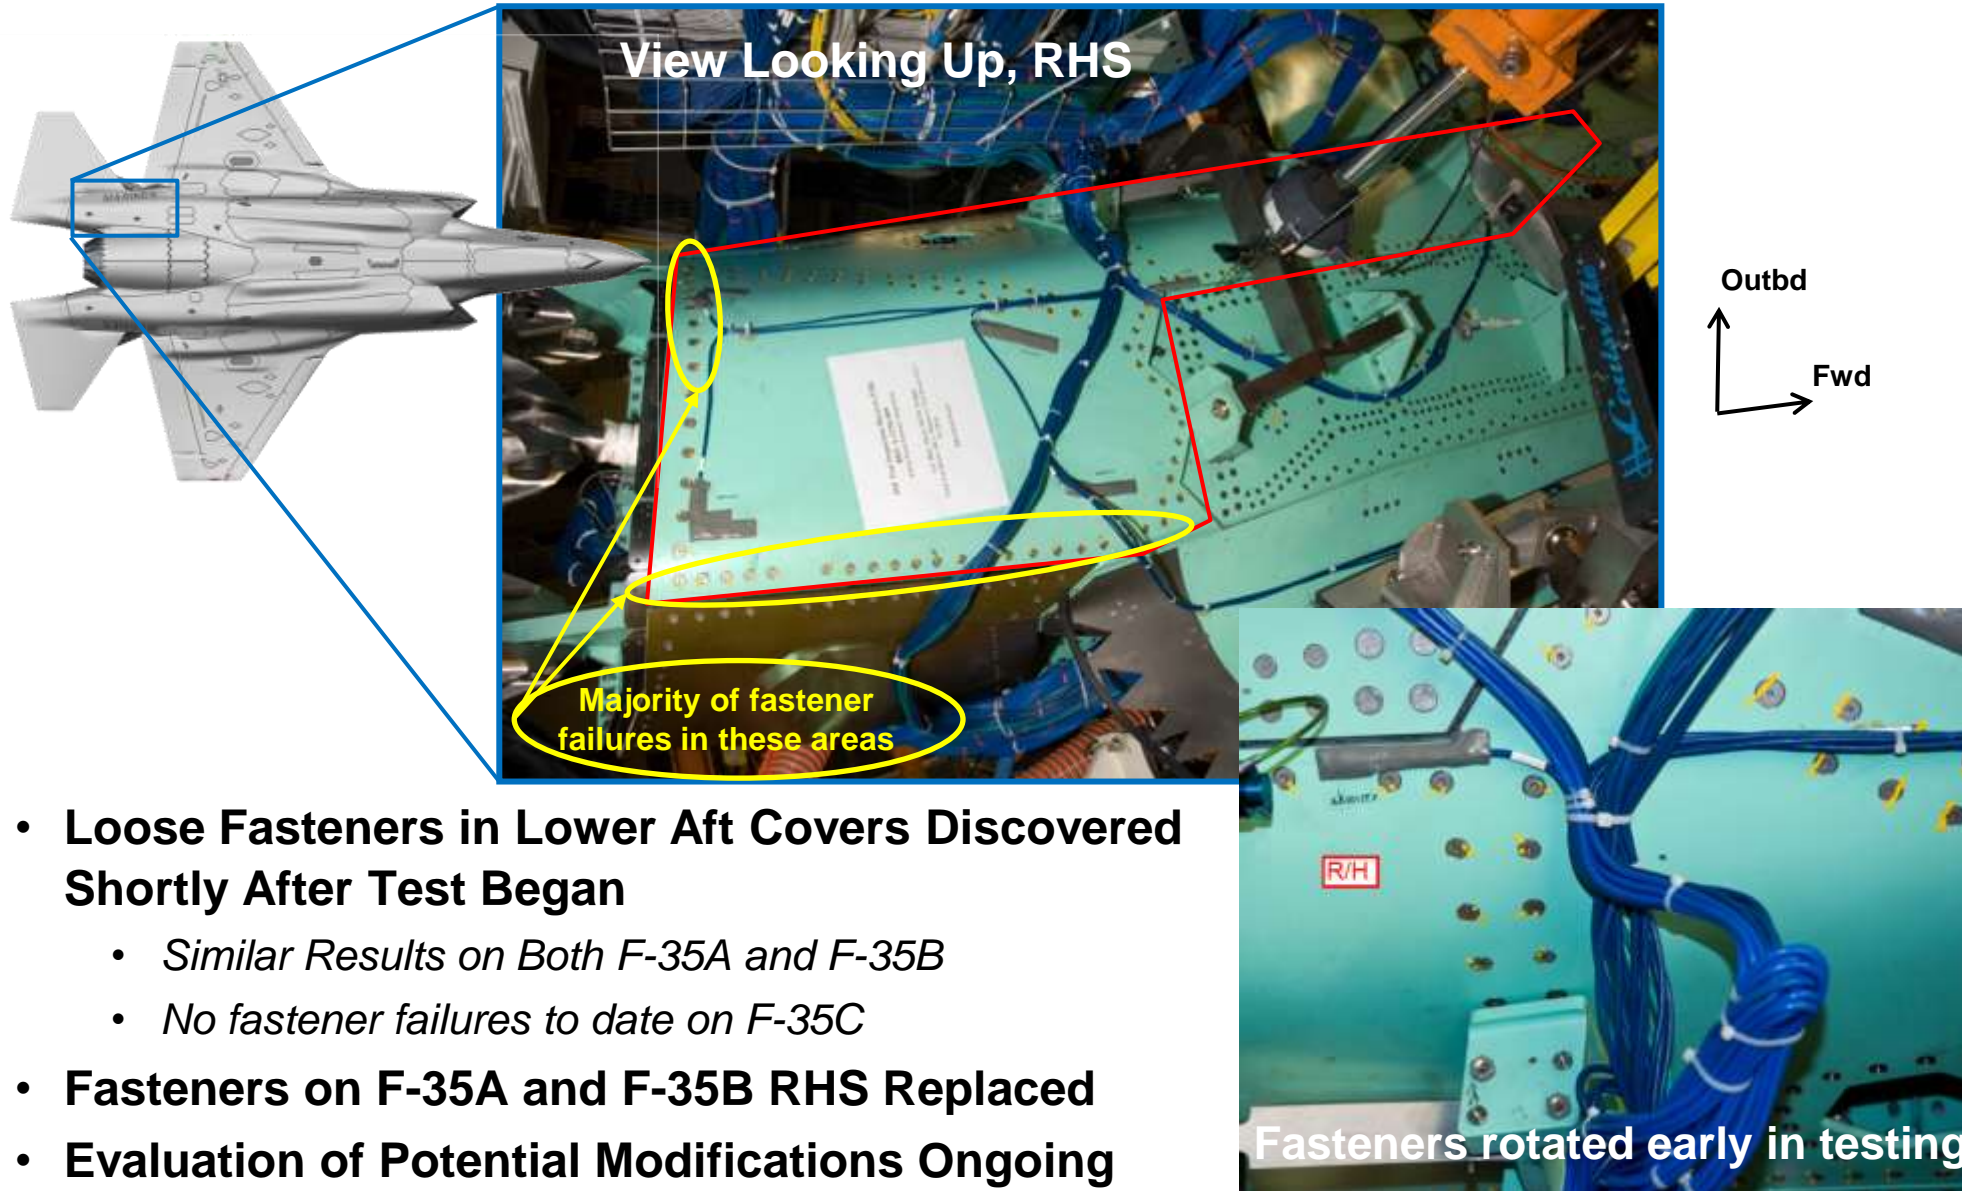
# Loose Fasteners on Lower Aft Access Panels – CTOL and STOVL

- **Loose Fasteners in Lower Aft Covers Discovered Shortly After Test Began**
  - *Similar Results on Both F-35A and F-35B*
  - *No fastener failures to date on F-35C*
- **Fasteners on F-35A and F-35B RHS Replaced**
- **Evaluation of Potential Modifications Ongoing**
- **No Evidence of Fastener Rotation on Flying A/C**

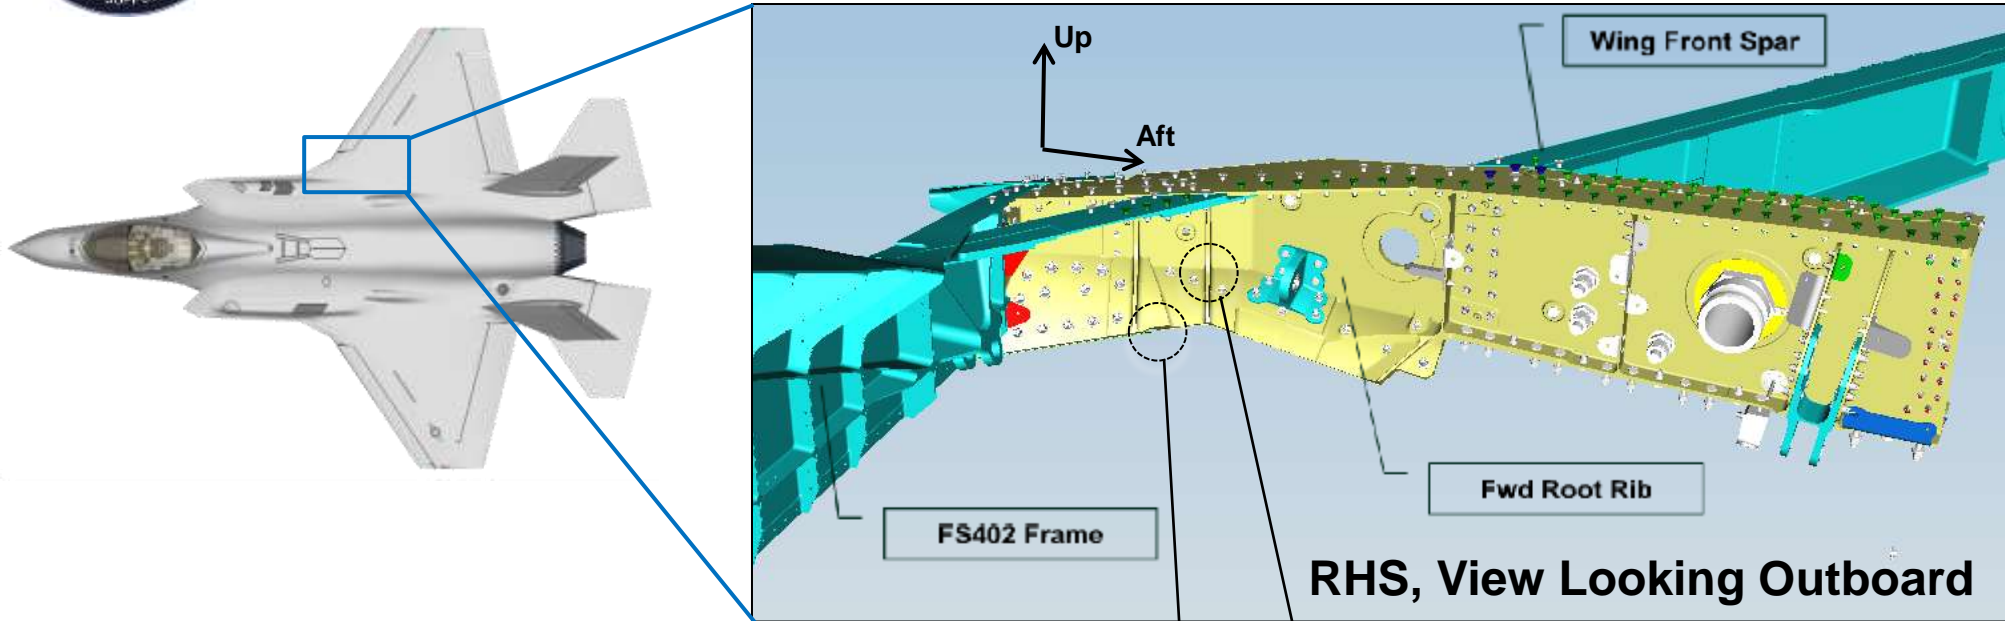
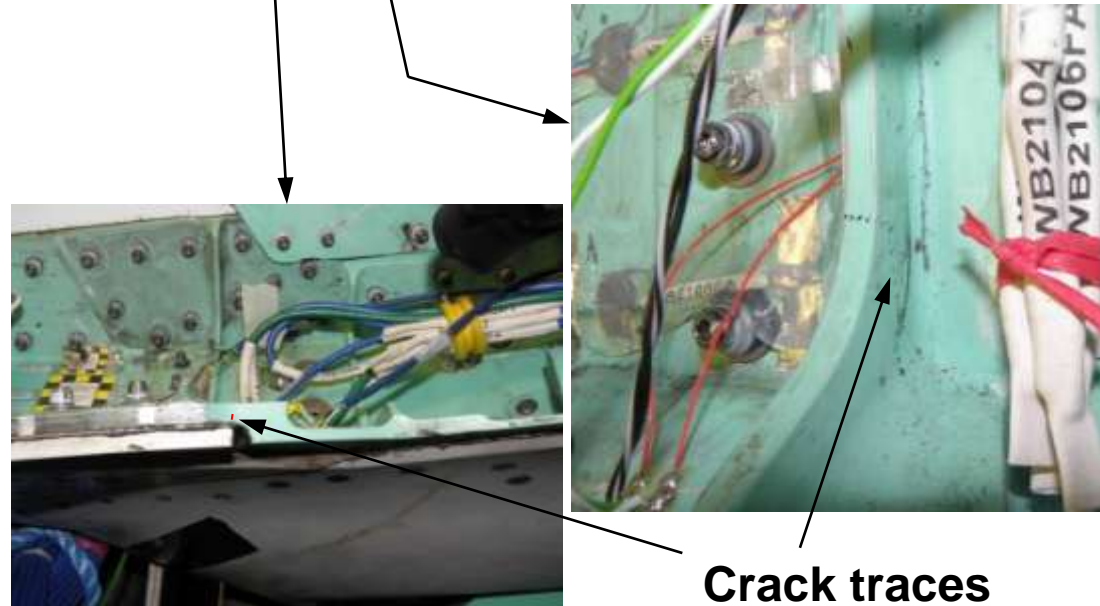
# CTOL Wing Forward Root Rib

- **Stiffener Crack Found at 2,117 Hours**
- **Lower Flange Crack Found at 5,089 Hours**
- **Declared Short Life Pre-Test**
- **Test Continued to 8,000 Hours**
  - *Crack Growth Monitored by Strain Gage Responses and Periodic Inspections*
- **Similar Crack Location and Geometry on LHS**

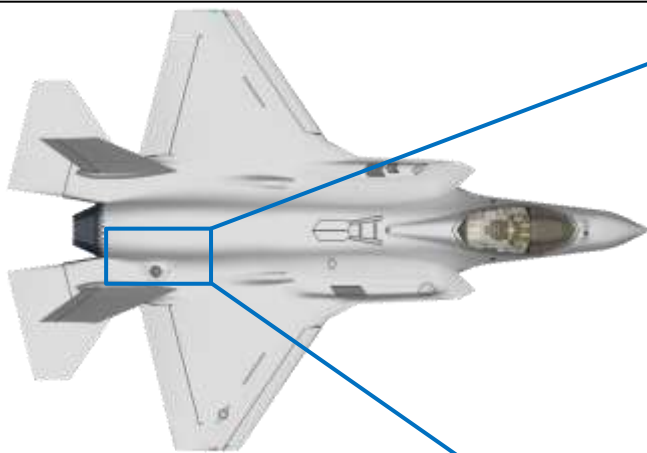
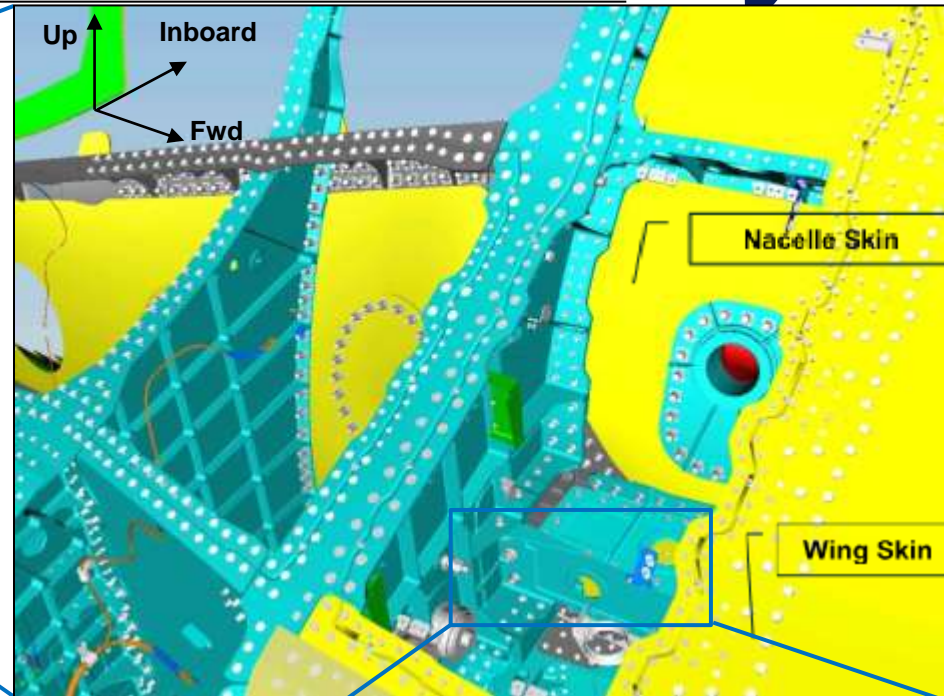
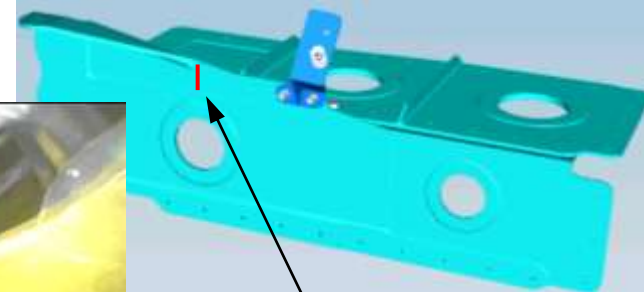
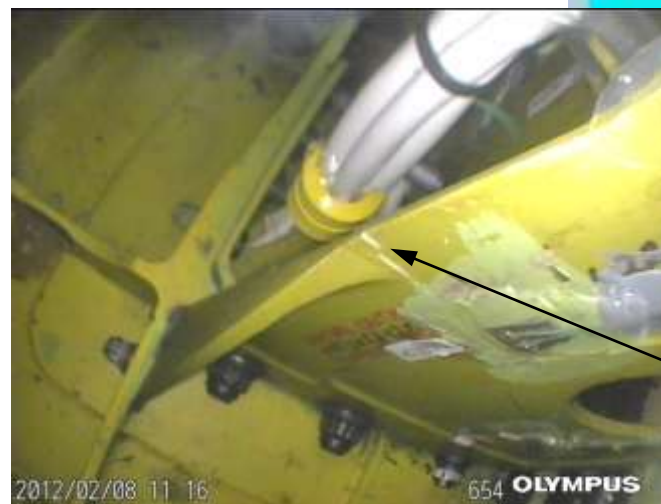
# CTOL Engine Thrust Mount Shear Web

RH side

Crack location

- **Shear Web Crack at 3,000 Hours**
  - *Initiation at Radius of Upper Flange Transition*
- **Test Continued to 8,000 Hours**
  - *Anomaly Monitored by Trending Strain Data and Periodic Inspections*
- **Similar Crack Discovered on LHS at 7,000 Hours**
- **Root Cause: Stress Concentration at Radius**

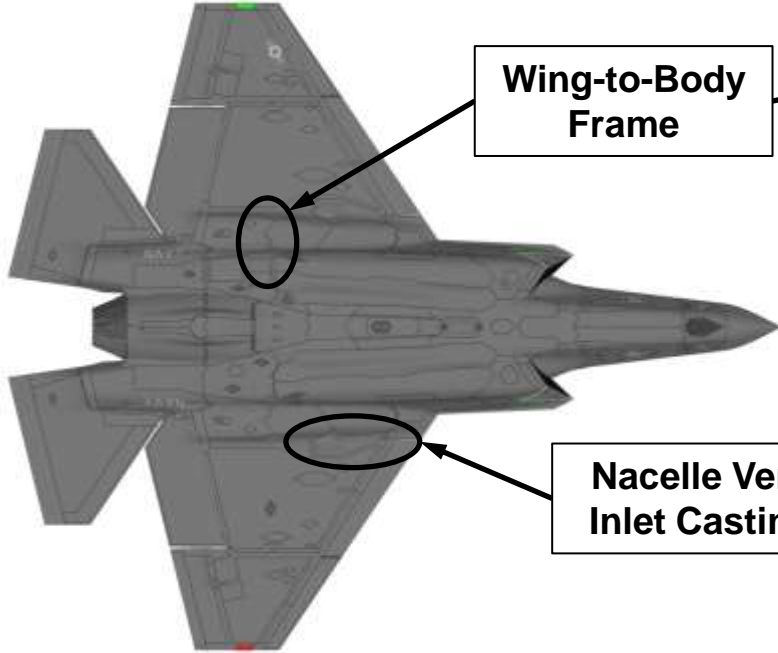
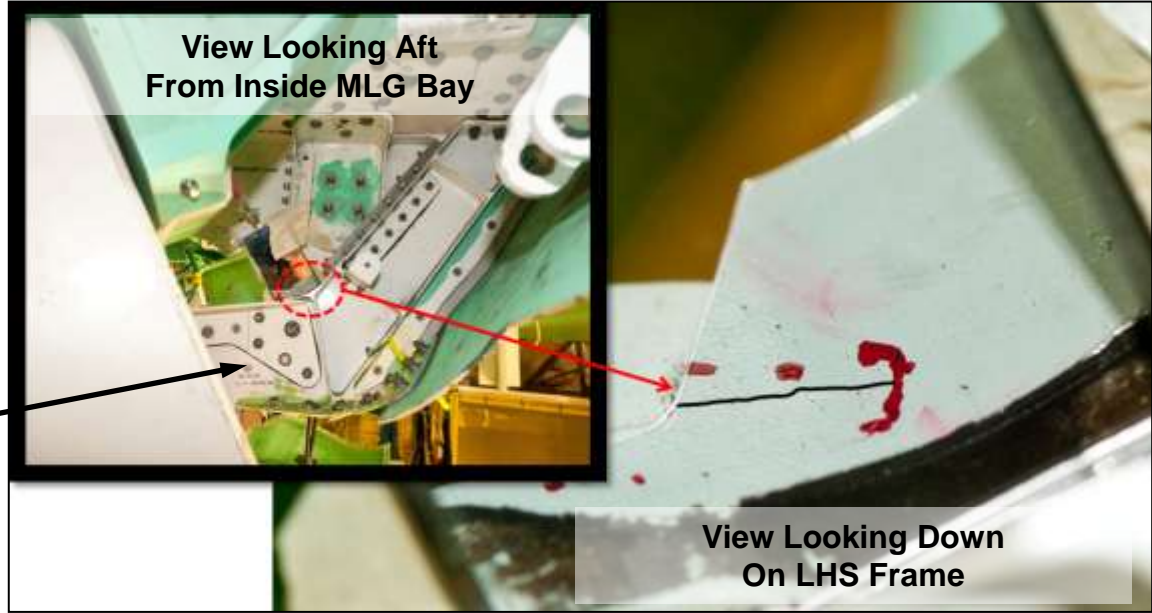
- FS 503 Frame Crack Discovered During Inspection Resulting From Change in Strain
- Known Short Life Location
- Test Article Mod Consists of Splicing in Production Configuration

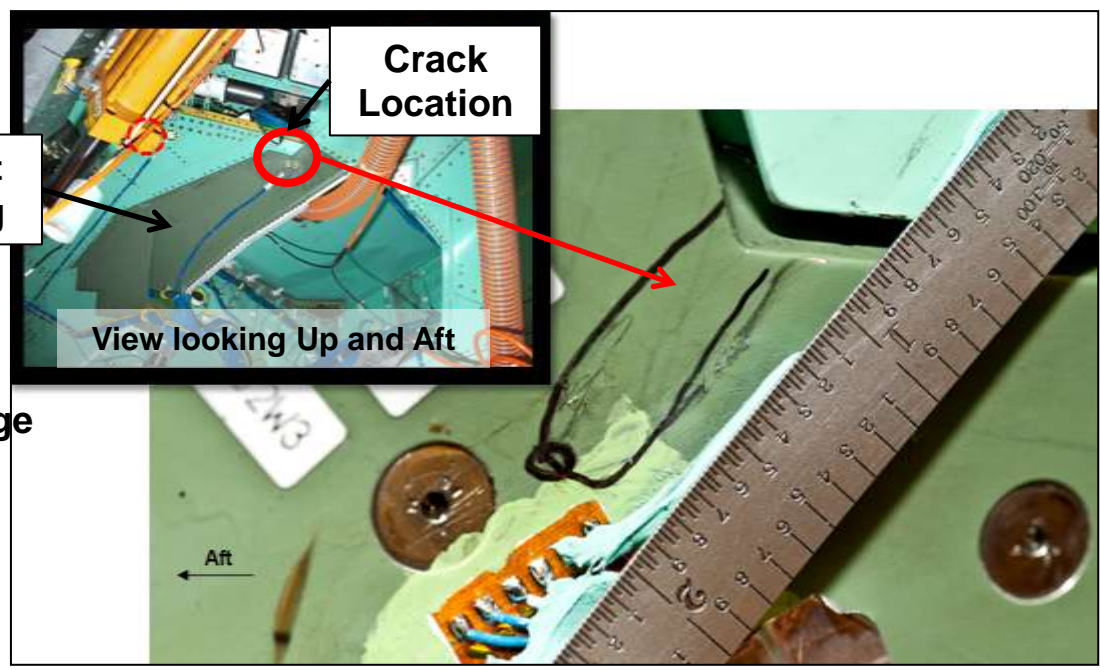
- Nacelle Vent Inlet Crack Discovered During Inspection Resulting From Change in Strain
- Known Short Life Location
- External Doublers Installed as Repair to Test Article

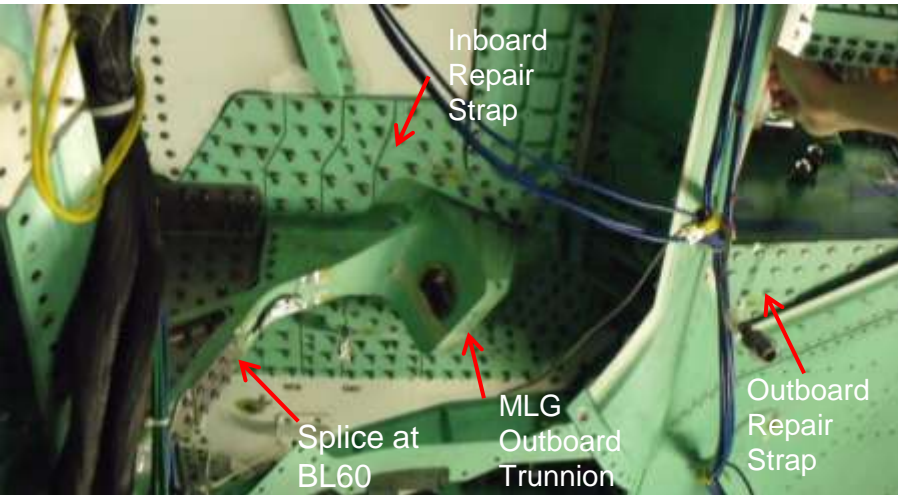
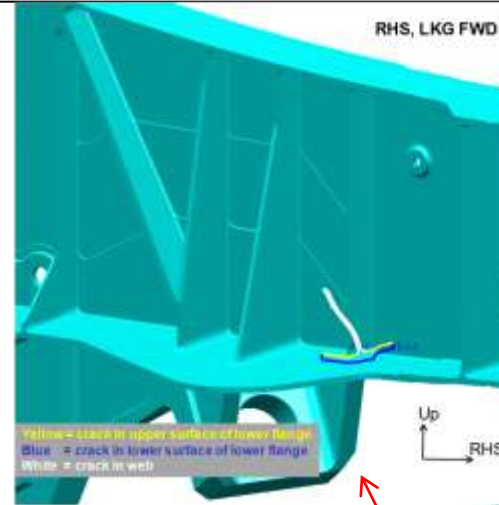
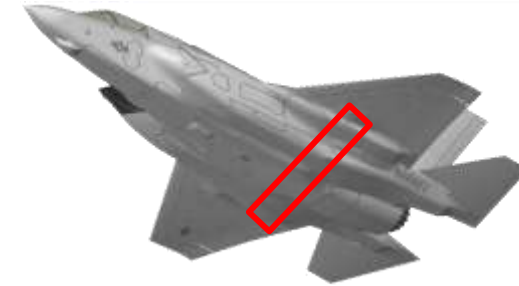
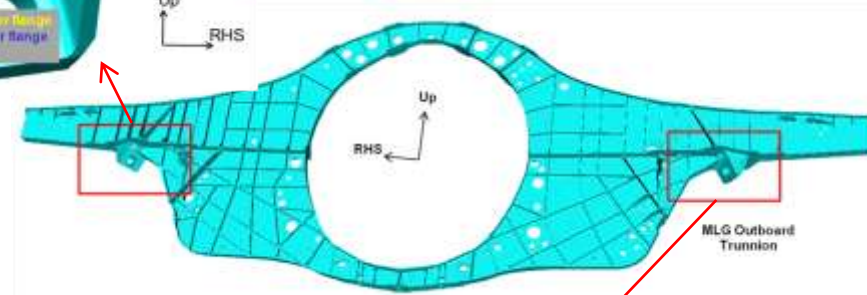
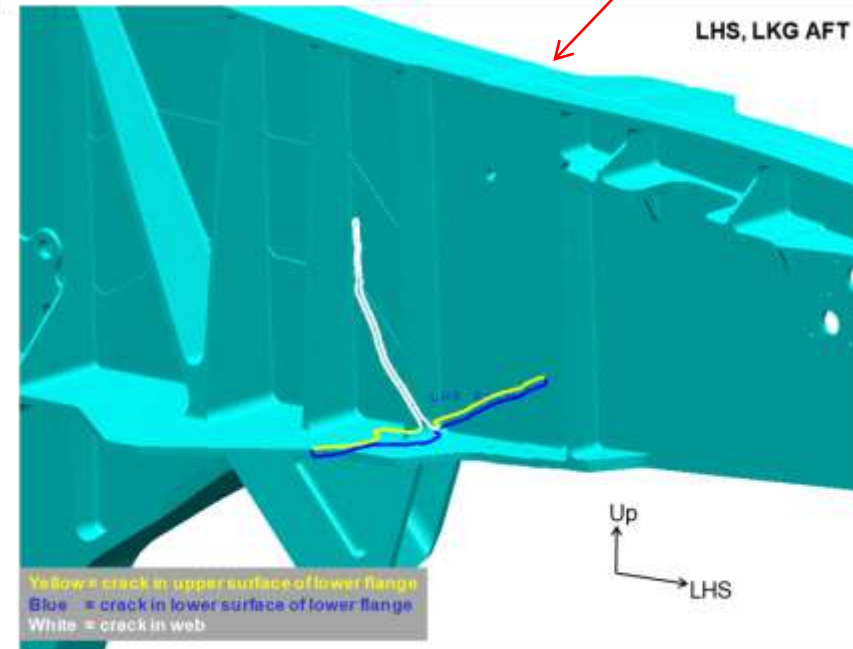
# STOVL FS 496 Bulkhead

**FS 496 Bulkhead Repair (LH) View  
Looking Up and Aft**

- **Cracks Discovered at 1,471 Maneuver Hours, Initiating at MLG Trunnion Radius**
- **Excised LH and RH Bulkhead Segments Outboard of BL60 and Replaced With**
  - *Production Redesign Geometry, LHS*
  - *SDD/LRIP Repair Geometry, RHS*
- **CTOL and CV Durability Test Articles Required Trunnion Blend**

<b>STOVL (BH-1)</b>	Aft Fuselage Lower Access Covers (LHS and RHS)	Loose fasteners found at 1,000 total hours; numerous fastener failures (LH & RH). Failed fasteners replaced; evaluation ongoing.
	FS 496 Bulkhead Cracks at MLG Trunnion, LHS and RHS	Cracks through bulkhead lower flange and web near MLG attachments at 1,471 maneuver hours. Required extensive repair and modifications to test article.
	NLG Retract Actuator Lug	Lugs failed at 7,182 total hours and replaced with pristine part, which failed again at 12,965 total hours into re-test.
	NLG Retract Actuator Backup Stiffener	Cracks detected at 9,878 total hours, repair required.
	WBD Cradle Lower Forward Lug	Lug crack discovered at 11,353 total hours; cradle replaced.
	WBD Outboard Hinge 4 Fitting	Hinge fitting failed at 13,327 total hours; fitting replaced.
	FS 503 RH Frame	Cracked at 1,753 maneuver hours as expected, testing continued with cracked part installed. Re-design installed on LH side of BH-1.

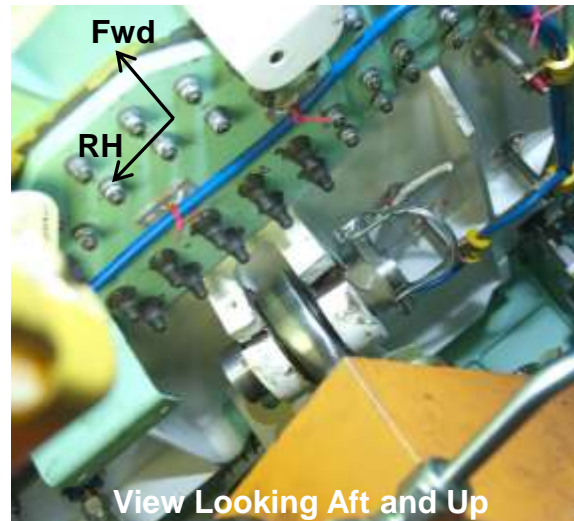
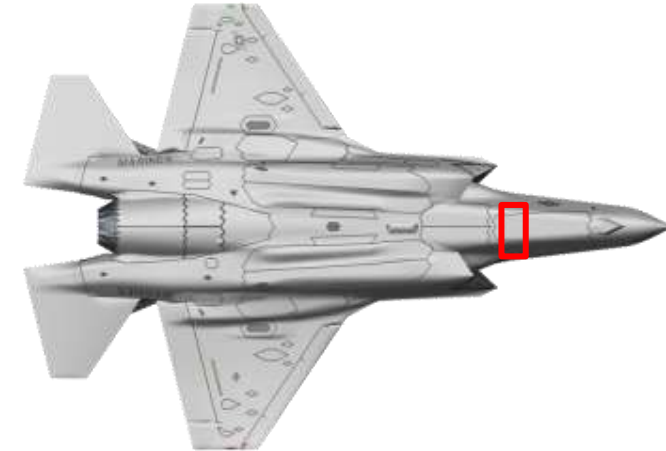
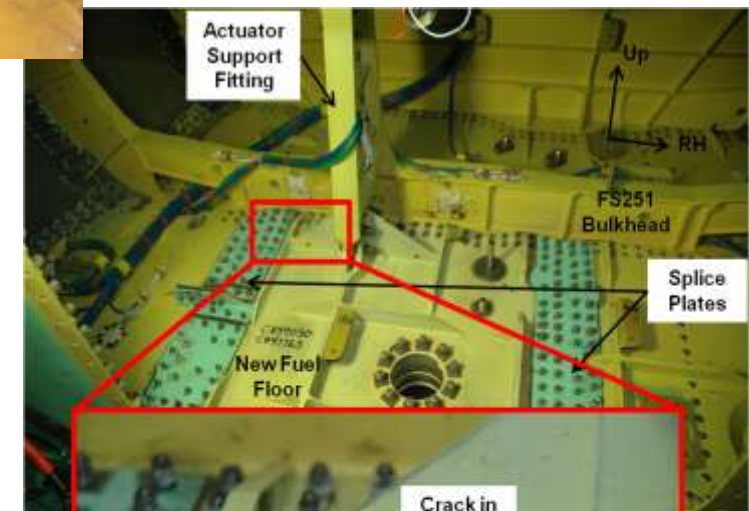
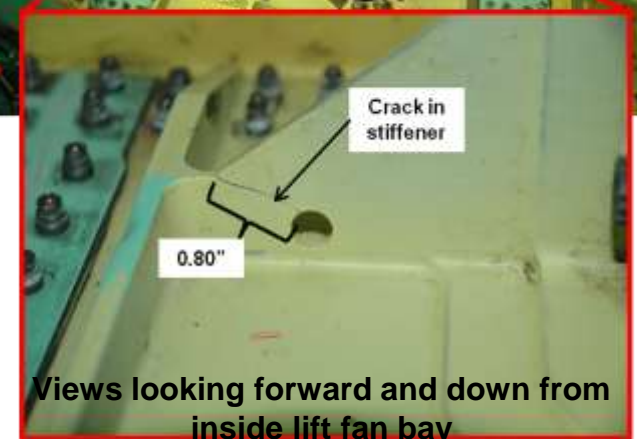
# STOVL Nose Landing Gear Retract Actuator Backup

- **Clevis Failed at 7,182 Hours**
  - *Root Cause: Bore Scratched During Bushing Install*
- **Clevis Replaced (Integral to Fuel Floor) and Test Re-started at Zero Hours**
- **Stiffeners Cracked (Through Thickness) at 9,878 Hours**
  - *Root Cause: Stress Concentration at Fillet Radius*
  - *LH Stiffener Repaired with Angle Brackets*
  - *Performed Trim of RH Stiffener Crack*
- **Second Failure of Clevis at 12,965 Hours**
  - *Root Cause: High Stress Concentrations due to Load Peaking*
- **Re-designs and Modifications Required for Production Aircraft (Increase Radius)**
- **CTOL and CV NLG Retract Actuator Lug Configurations are Significantly Different**

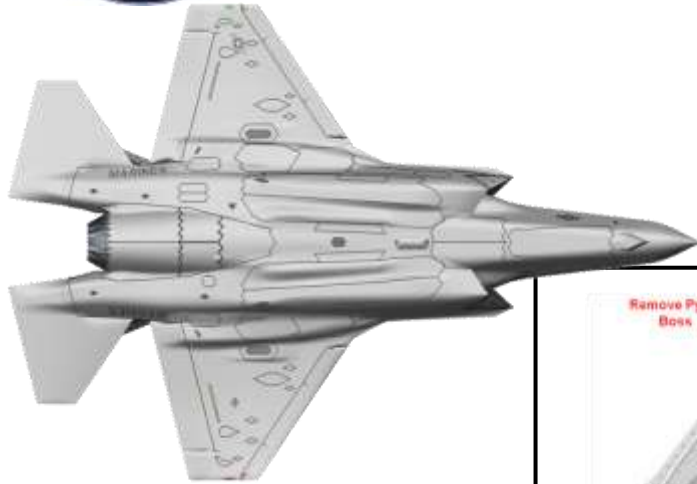
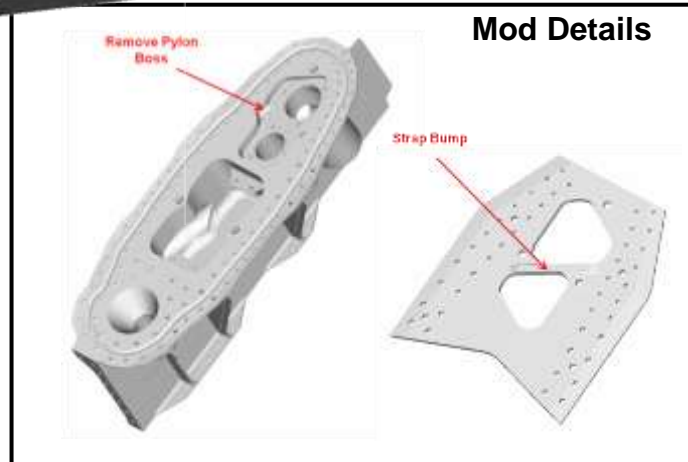
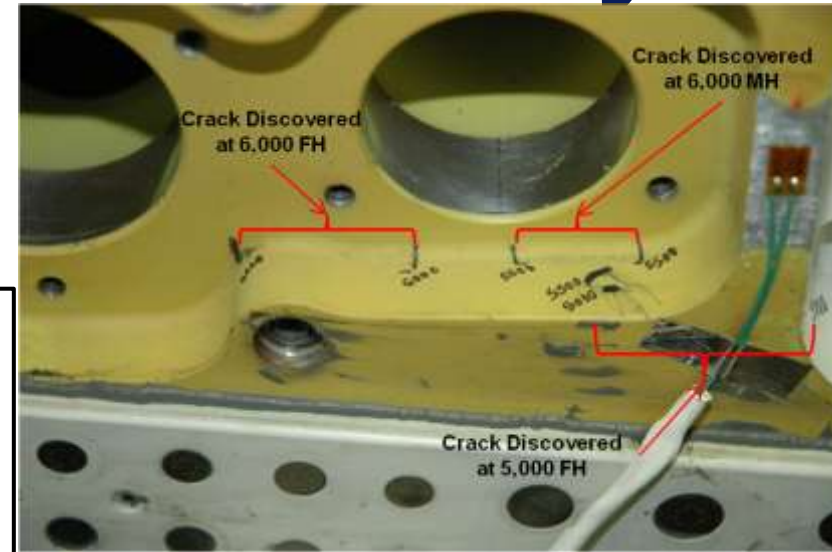
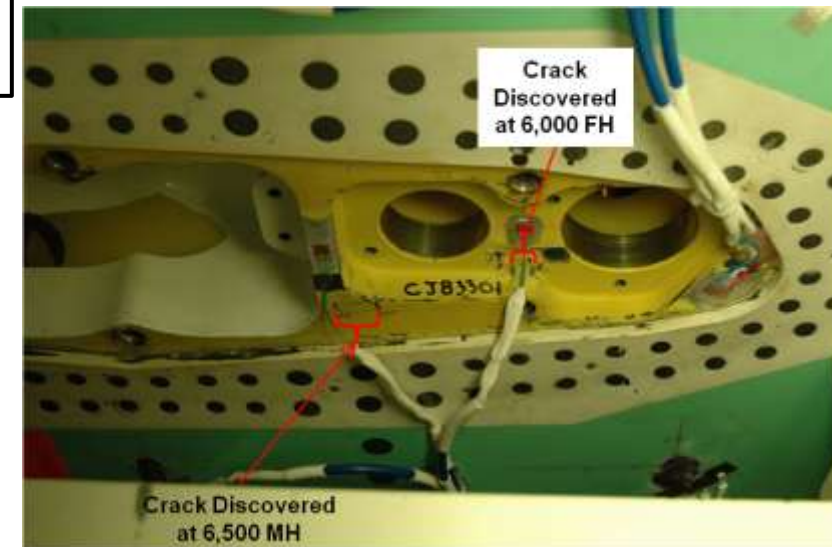
# STOVL Wing Pylon Aft Ribs

View Looking Inboard and Up (Station 3 – LH)

View Looking Inboard and Up (Station 9 – RH)

- **Cracks Discovered in Station 3 (LH) Aft Rib at 5,000 Hours and Station 9 (RH) Aft Rib at 6,000 Hours**
  - *Both are Known Short Life Locations; Crack Geometry and Timing as Predicted*
  - *Cracks Stop Drilled at 6,000 Hours*
  - *External Straps Installed (LH and RH) at 7,000 Hours*
- **Engineering for Modification and Re-designs for Production Aircraft Already Defined**

IPP Shear Web Lug Crack	Cracked at 2,950 maneuver hours. Joint disconnected and testing continued. Evaluation under way.
	3BSM Door Uplock Failure	3BSM Door Uplock mechanism spline failed at 3,862 maneuver hours.
	Pylon Station 3/9 Aft Rib	Station 3 (LH) crack discovered at 5,000 total hours; Station 9 (RH) crack discovered at 6,000 total hours. Crack locations and timing expected. Cracks stop drilled at 6,000 total hours, and external straps installed at 7,000 flight hours.
	RH Nacelle Vent Inlet	Crack detected at 5,508 maneuver hours.
FS 472 Bulkhead Flange Crack	Cracked at 6,750 maneuver hours. Stop drilled crack tip and continued testing. Root cause analysis in work.

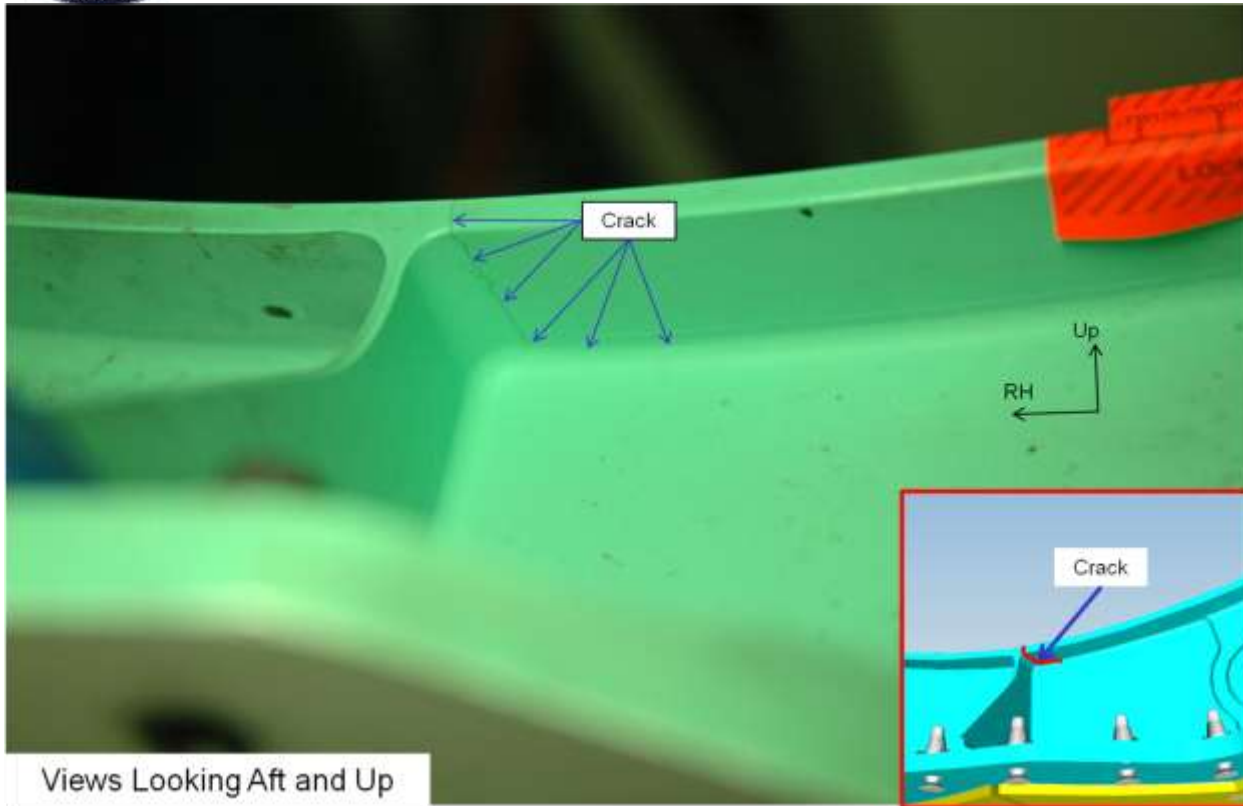
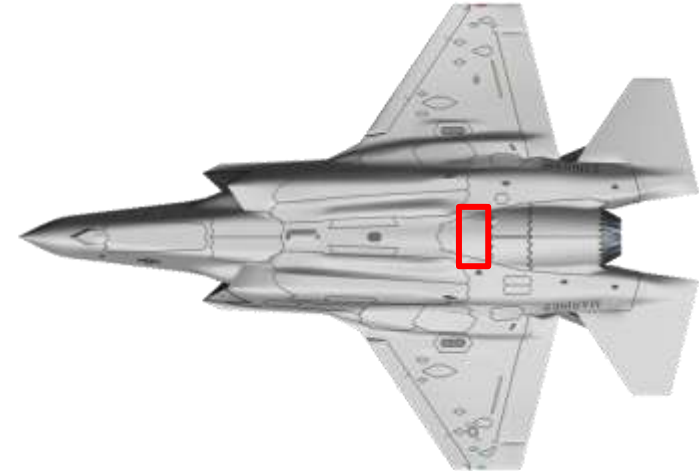
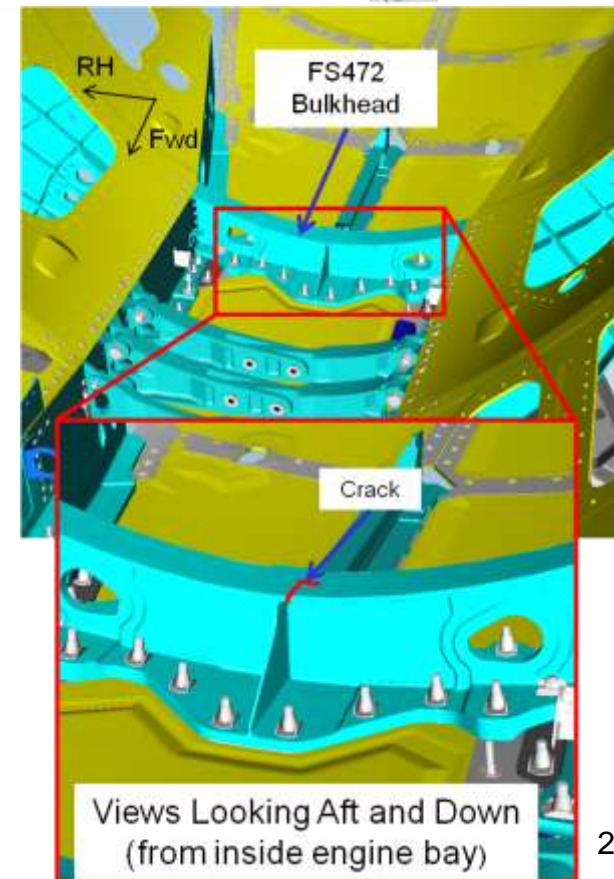
# STOVL FS 472 Bulkhead

Views Looking Aft and Up

Views Looking Aft and Down  
(from inside engine bay)

- **FS472 Bulkhead Cracked at 6,750 Maneuver Hours**
  - *Crack is Through Thickness of Upper Flange*
  - *Extends From Free Edge Aft to Web, then Outboard Along Web-to-Flange Radius*
  - *Root Cause In Work*
- **Stop Drilled Crack Tip and Continued Testing**
- **Further Actions Required at 8,000 Hours**

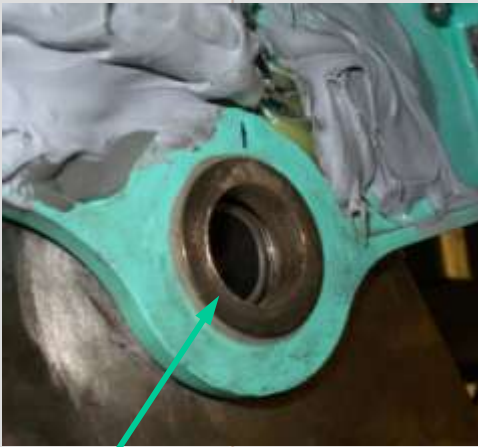
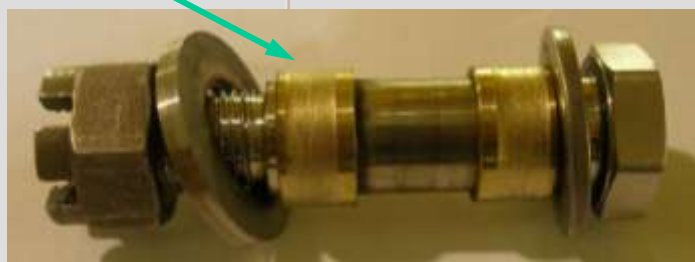
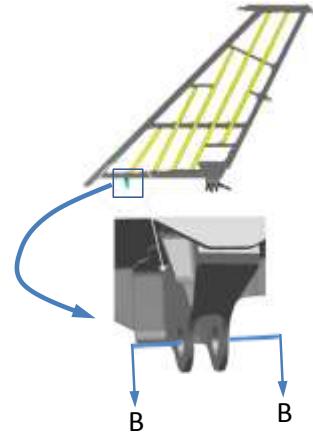
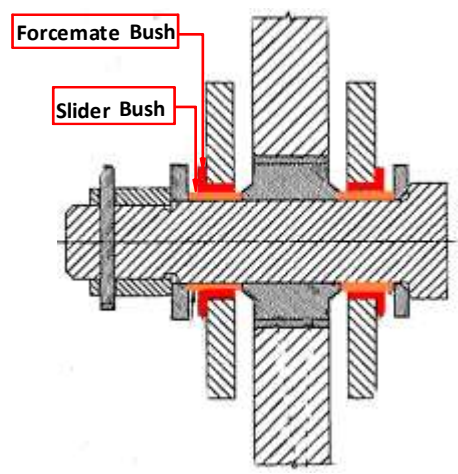
## Original Bushing Material Configuration

- ForceMate: AL-Ni Bronze
- Slider: AL-Ni Bronze
- At 1,753 Hours Testing Exposure

Worn ForceMate  
Worn Slider Bushes

Sect B-B

CTOL	FS 575 Forward Shear Tie	Discovered premature wear on initial bushing configuration at 1,753 total hours. Replaced bushing with different material. Replaced slip bushings at 12,000 total hours. Modified configuration successfully cycled for 10,000 total hours, exceeding the 8,000 hour wear requirement.
	Rudder Base Bolt and Slip Bushing	Parts replaced at 12,000 total hours due to wear which affected test performance. Strength and functionality undiminished; no design change necessary for flying aircraft.
	Fixed Link Tie-Rod Assembly	Spherical bearing and liner worn without degradation to strength & functionality. Replaced at 7,500 total hours to improve testing performance.
	Rudder Hinge 3 Nut and Locking Washer	Determined to be nonfunctional at 12,000 total hours due to wear. Original installation exceeded wear requirement of 8,000 hours.
	Rudder Hinge 3 Pin	Excessive wear at 16,000 total hours, however maintained strength & functional capability throughout test.

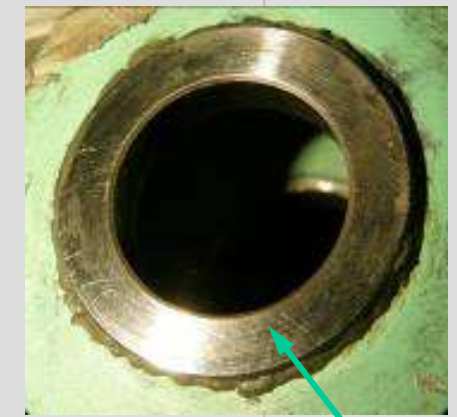
## Retro-Fit Bushing Material Configuration

- ForceMate: Nitronic 60 Grade C
- Slider: AL-Ni Bronze, molykote
- At 10,247 Hours Testing Exposure

Within Design ForceMate  
Worn Slider Bushes
