# Overview of the Full Scale Durability Tests on F-35 Lightning II Program

**Marguerite E. Christian**  
**Senior Manager**  
**Structures Test**  
*F-35 Structures Development*  
*Lockheed Martin Aeronautics Company*

*2012 Aircraft Structural Integrity Program (ASIP) Conference*  
*November 27-29, 2012*  
*San Antonio, TX*

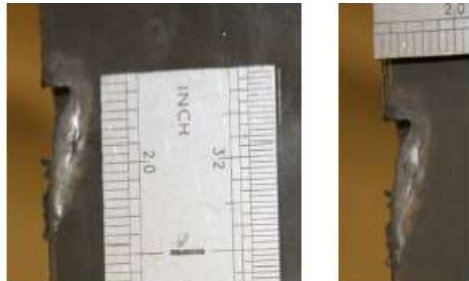
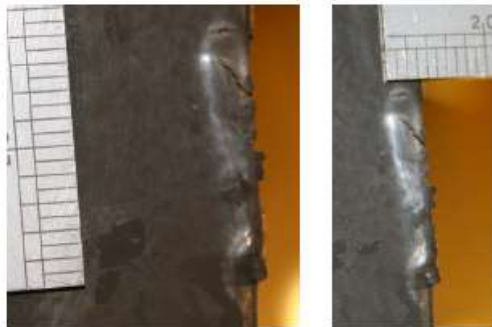
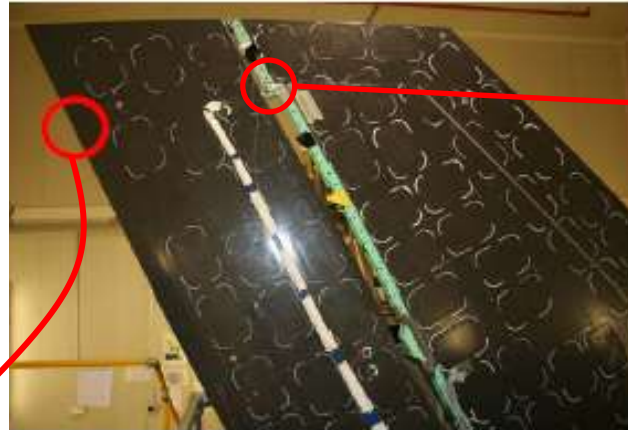
## Rudder V-Tip

- C-Beam Load Fixture Contacted Rudder Aft Edge (V-tip) During Maneuver Testing

View Looking Outboard

View Looking Inboard

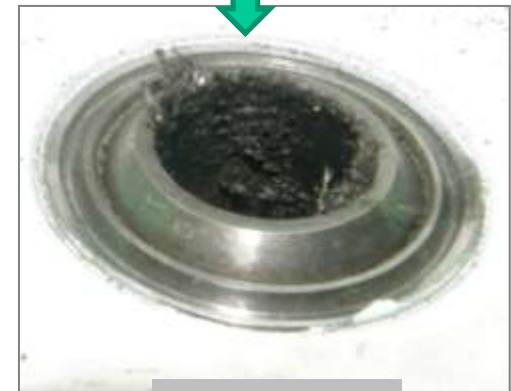
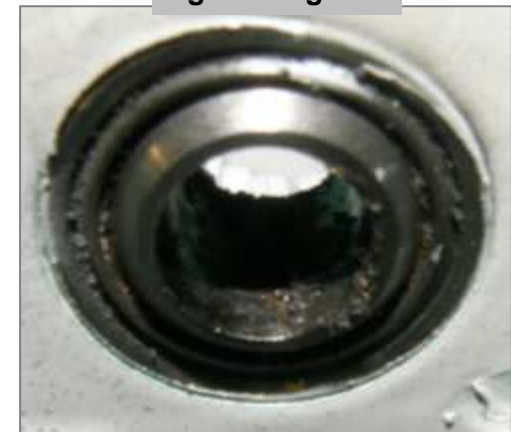
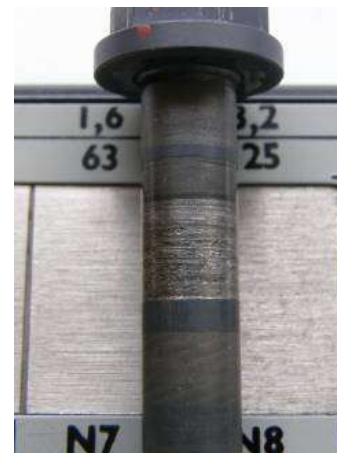
## Rudder Hinge 3 Lug

- Severe Over Excitation During Vibration Survey

Looking Down

Lug Bearing Liner

Looking Up

### Hinge 4 Bolt

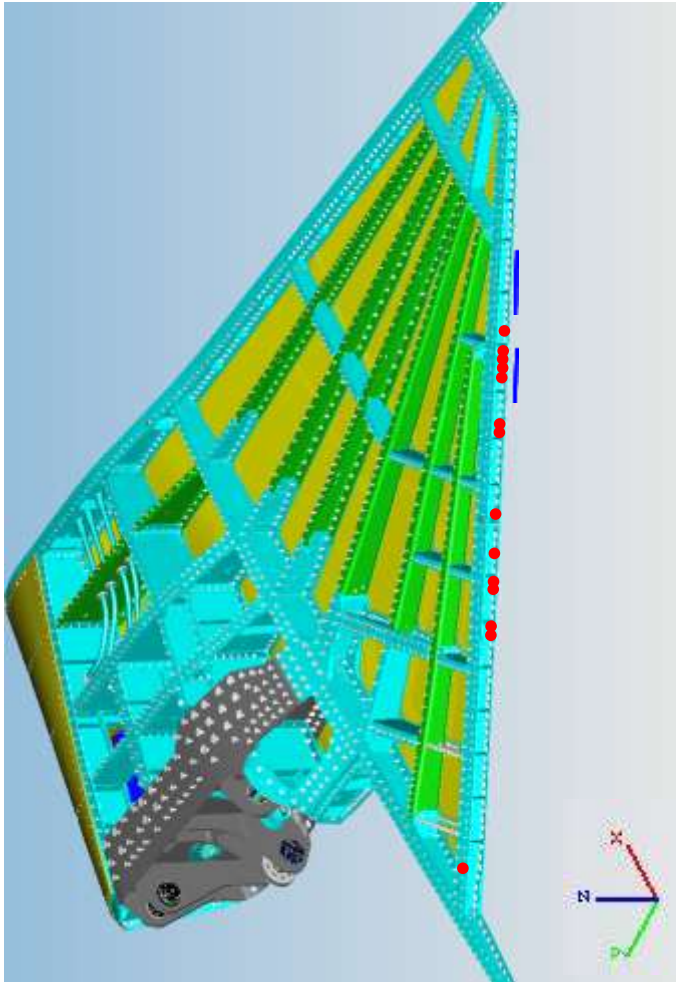
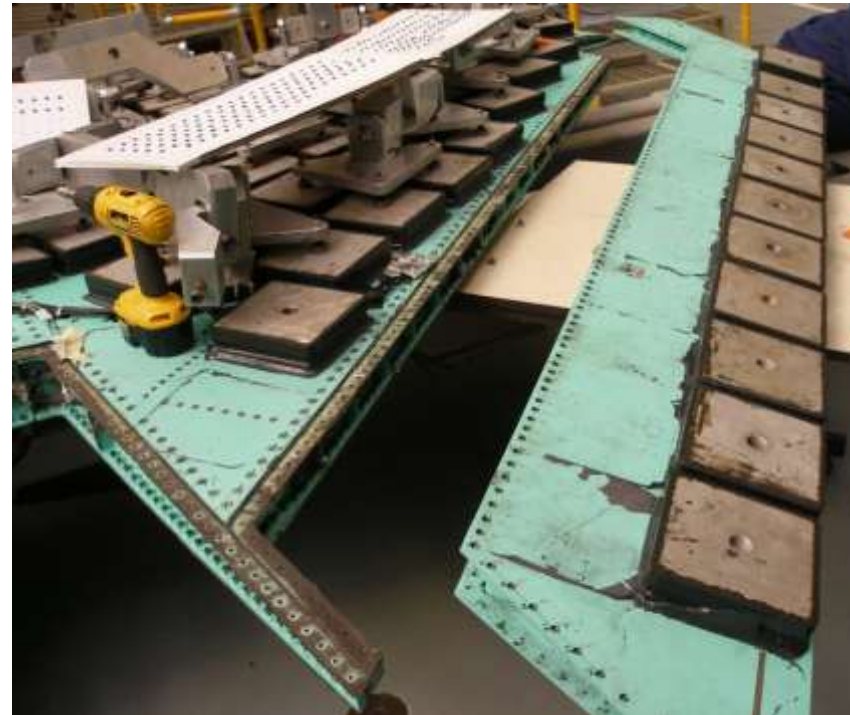
## CV HT (4DB6)

**14 Fastener Failures During 1<sup>st</sup> LT (8000 flight hours) Testing, Along Leading Edge**

- **Modified Leading Edge After Completion of 1<sup>st</sup> Lifetime, 8000 Flight Hours**
  - *Increased Fastener Diameter to ¼ inch*
  - *Changed Fastener Material From Inconel to Titanium*
  - *Decreased Bolt to Hole Clearance*
- **Completed 3000 Flight Hours With Modified Configuration and No Fastener Failures**
