Weld Joint Discontinuities

Discontinuity Classifications

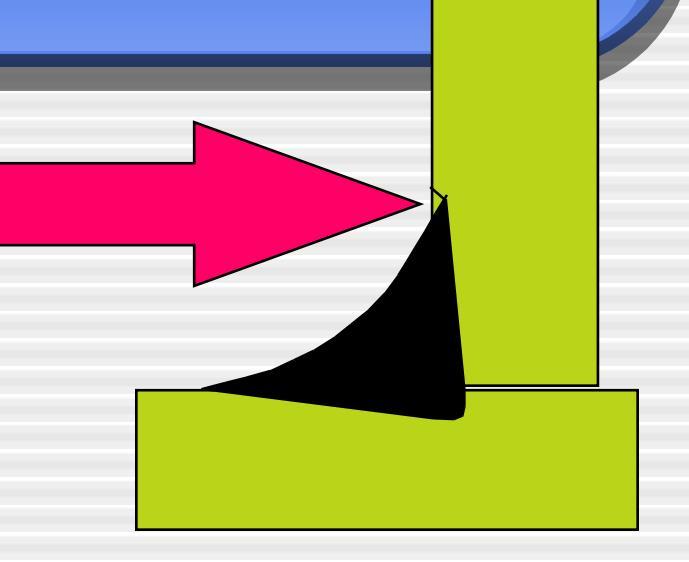
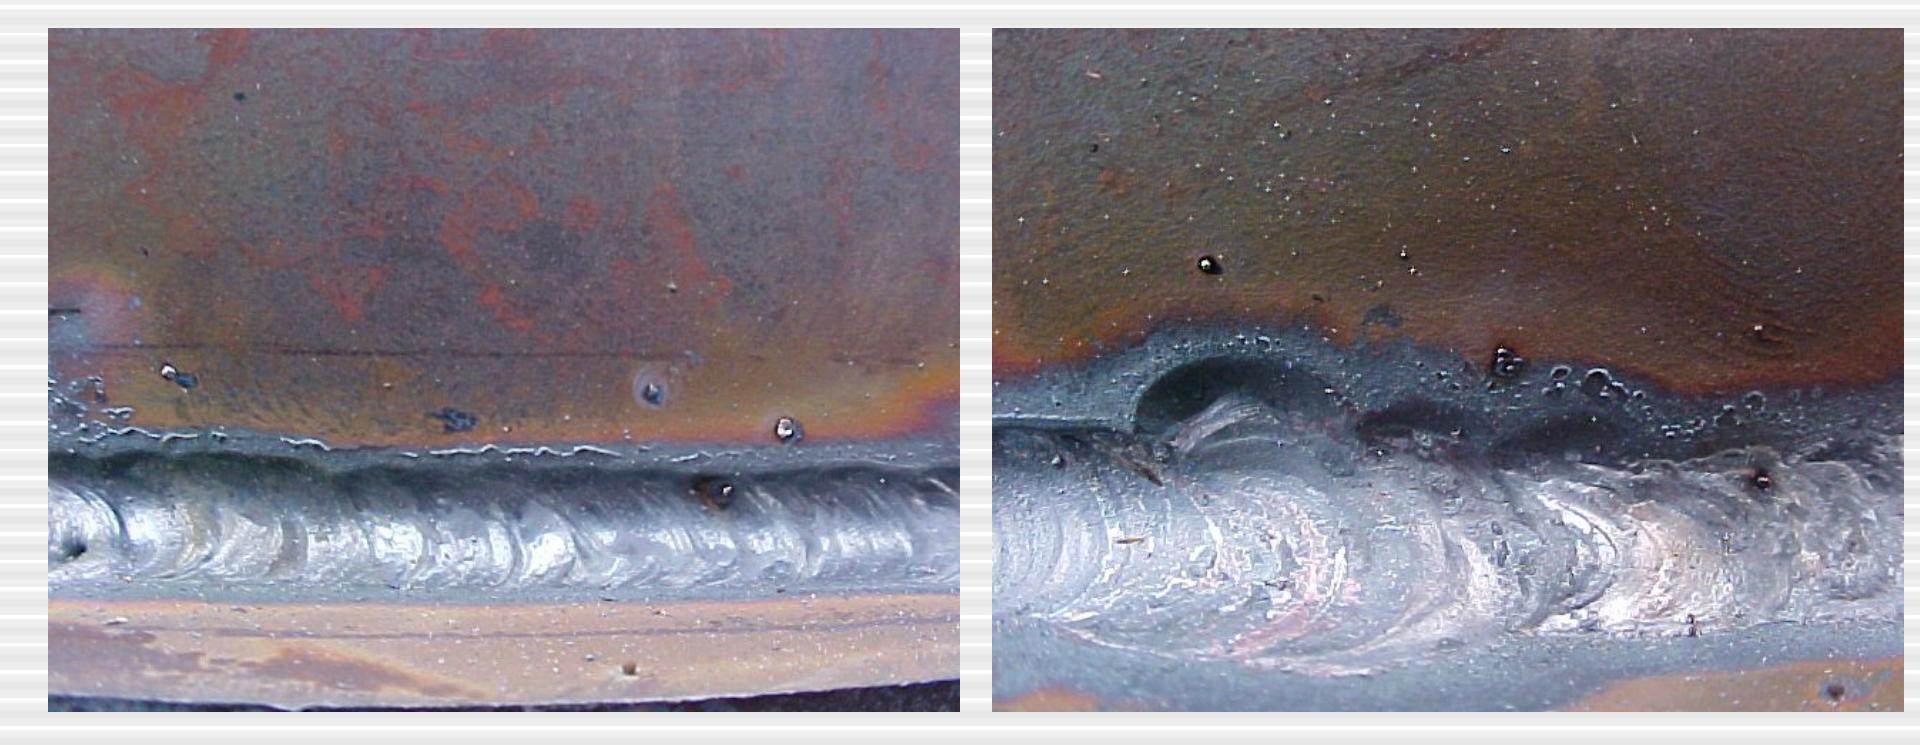
UNDERCUT

- **Definition:** A groove cut at the toe of the weld and left unfilled.
- **Cause:** High amperage, electrode angle, long arc length, rust

- **Prevention:** Set machine on scrap metal. Clean metal before welding.
- **Repair:** Weld with smaller electrode, sometimes must be low hydrogen with preheat. Sometimes must gouge first.

- Undercut typically has an allowable limit.
- Different codes and standards vary greatly in the allowable amount.
- Plate the lesser of 1/32" or 5% (typ.)

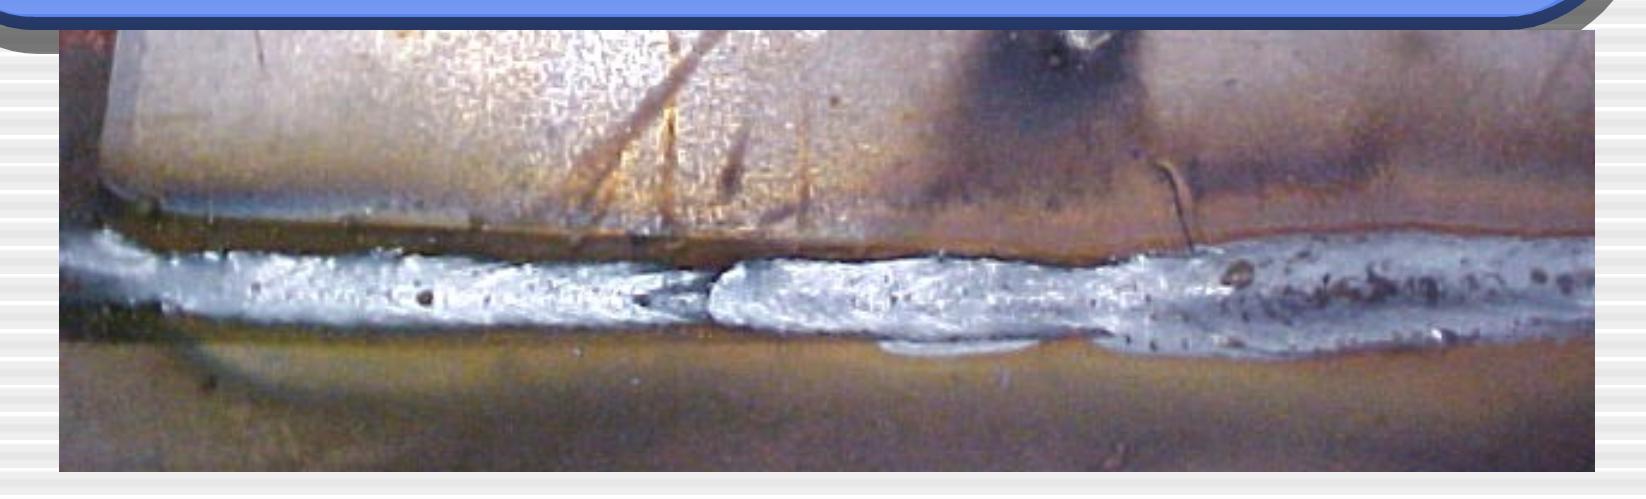
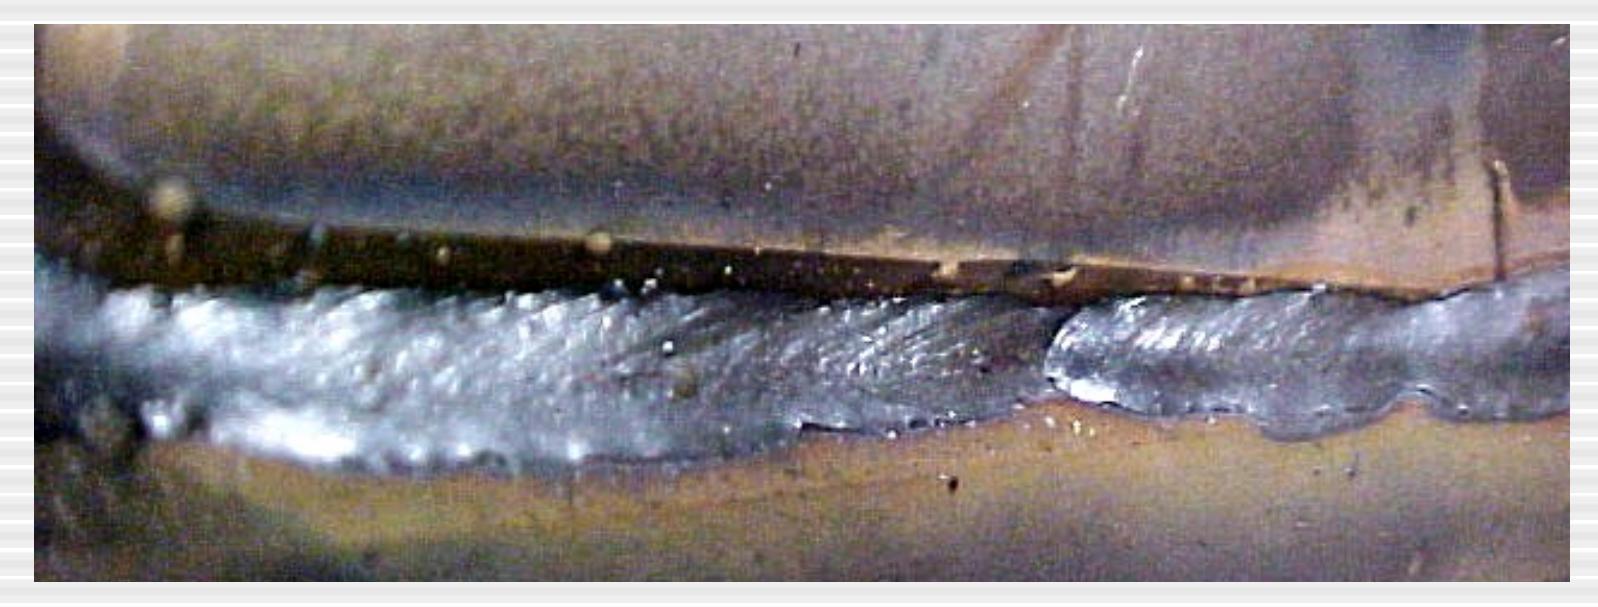
UNDERFILL

- The weld surface is below the adjacent surfaces of the base metal
- Cause: Improper welding techniques
- Prevention: Apply proper welding techniques for the weld type and position. Use stripper beads before the cover pass.
- Repair: Simply weld to fill. May require preparation by grinding.

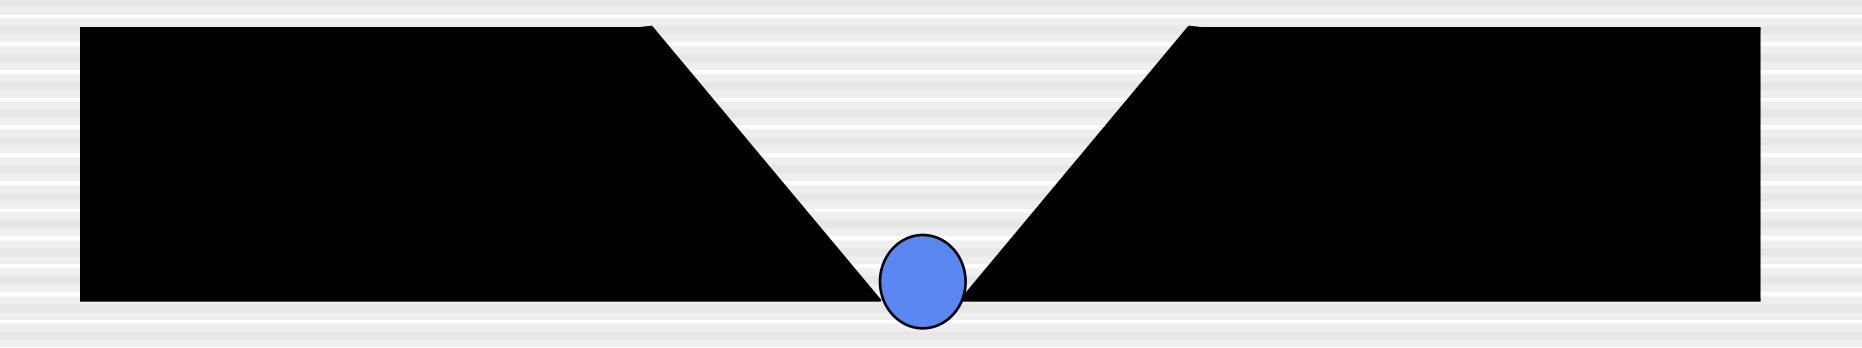
Cause for Insufficient Fill at the Root

- Some liquids, like water or molten steel, try to cover as much surface area of whatever they are in contact with as possible.
- Welding a root pass too wide can also cause the bead to sag (overhead position).

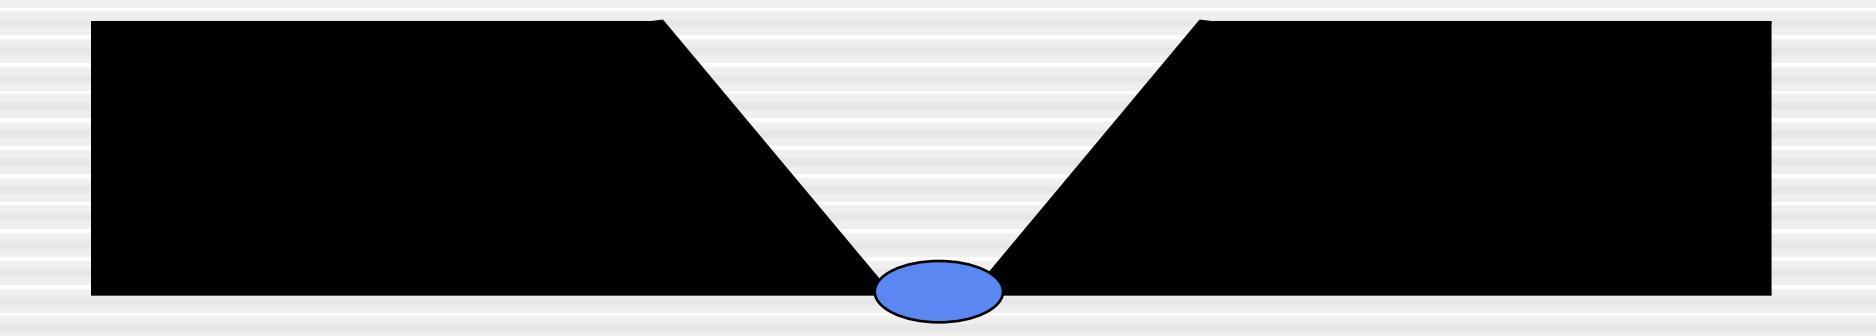
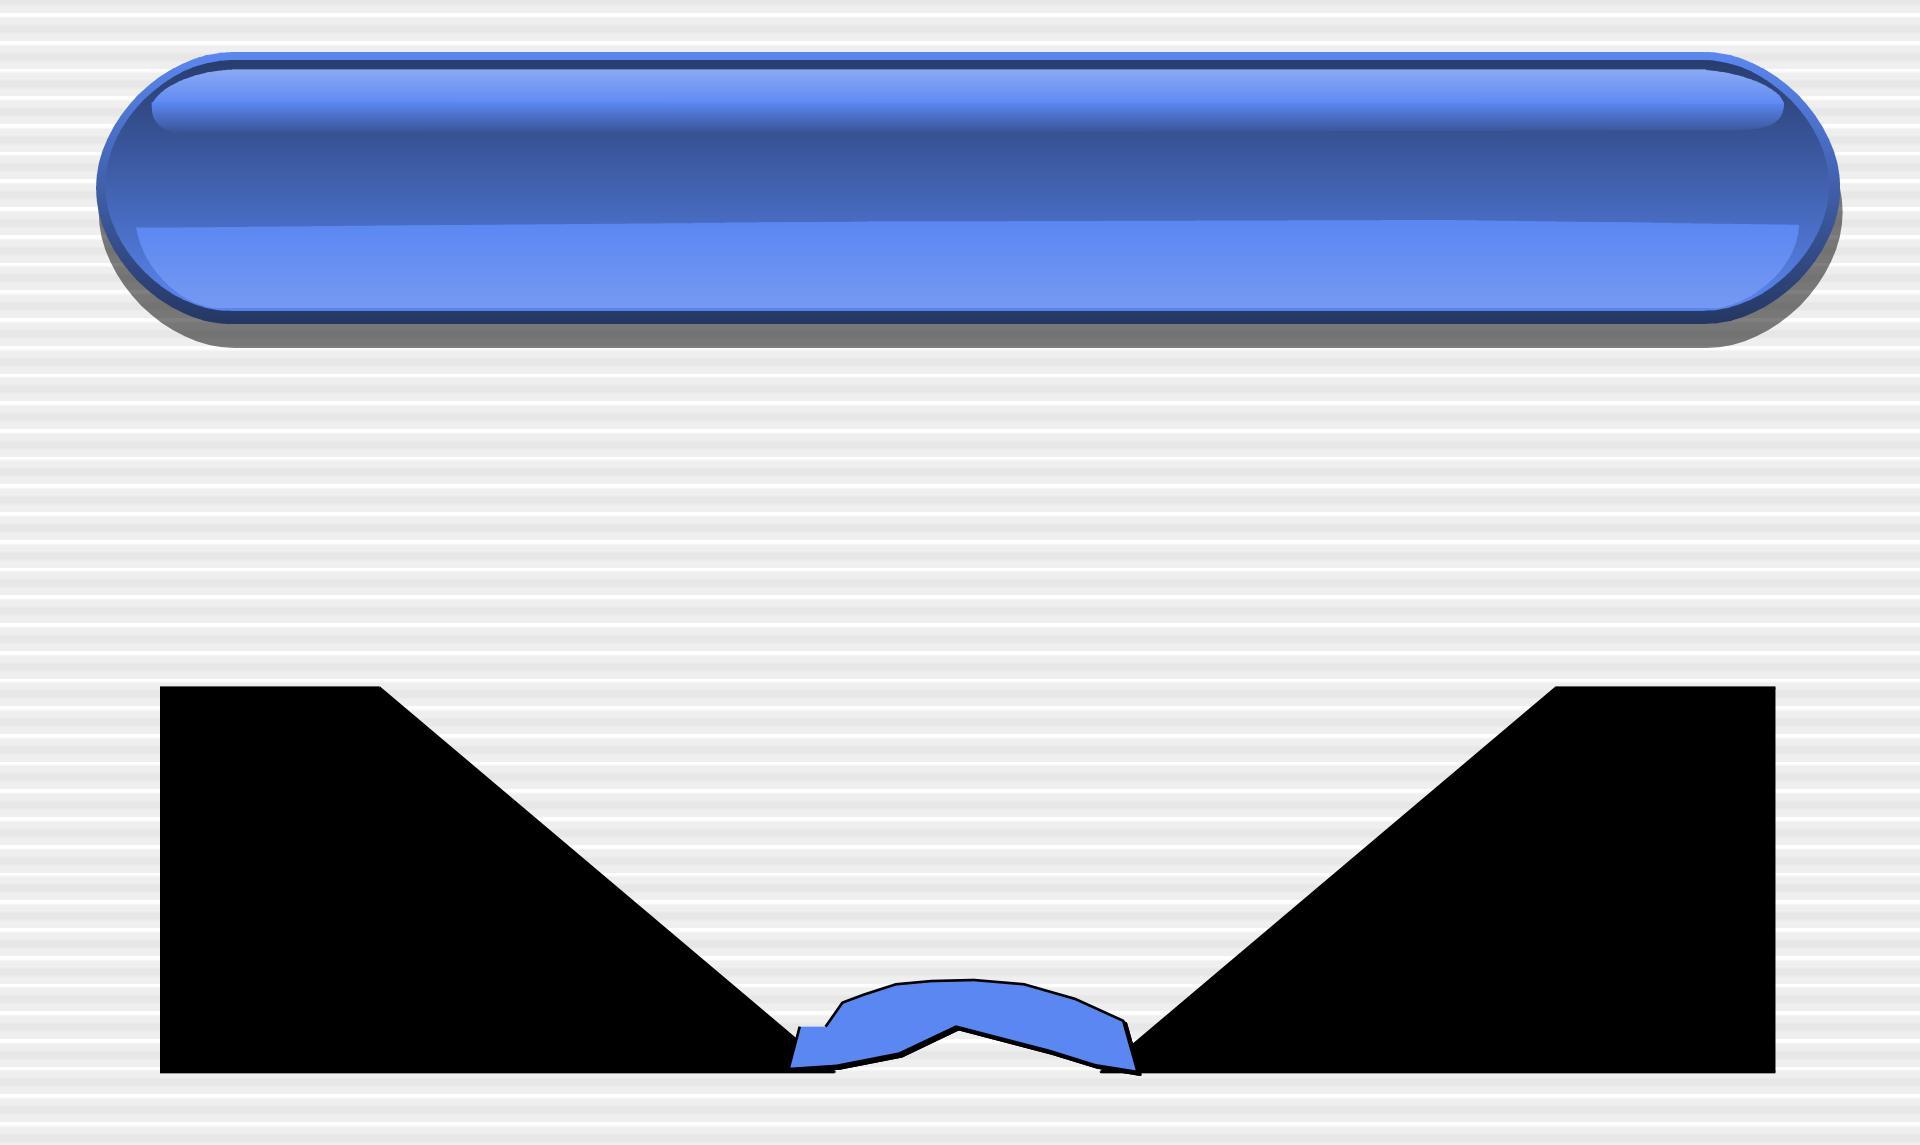
Cause for Insufficient Fill at the Root

Ideally

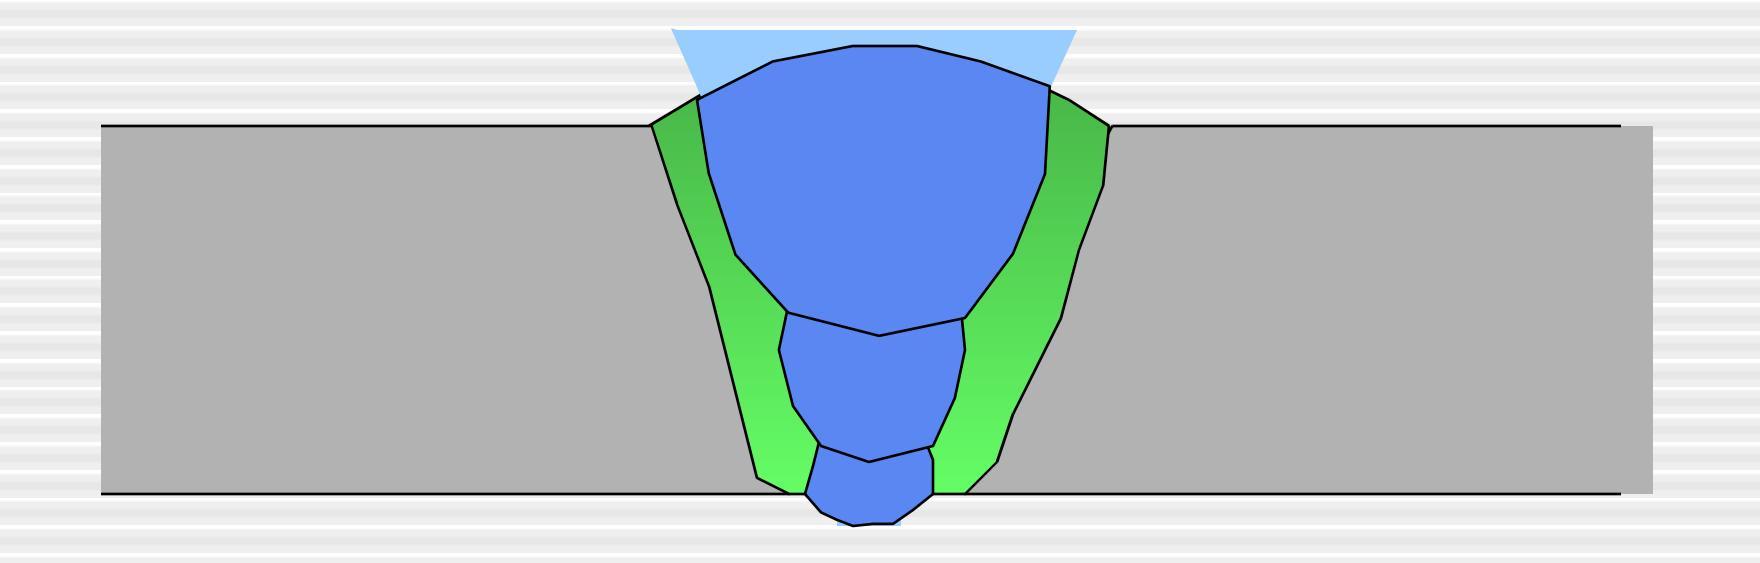
Remove root pass by grinding

- Recreate the groove geometry as closely as possible.
- Use a saw or die grinder and 1/16 1/8" cut off wheel to recreate root opening.
 - Repairs sometimes require a smaller electrode.
- Open the groove angle. Be careful to leave the proper root face dimension.
- Feather the start and stop to blend smoothly into and out of the existing weld.

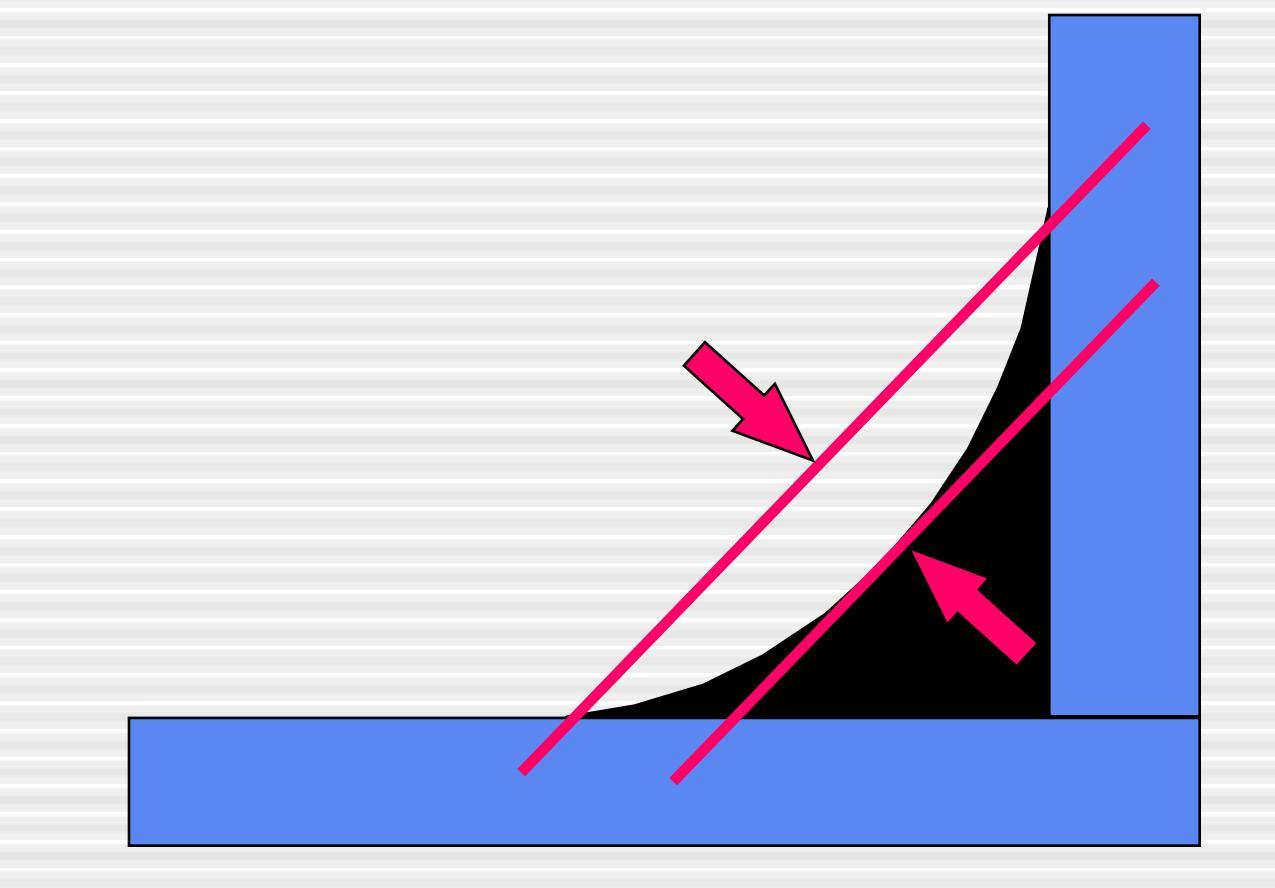
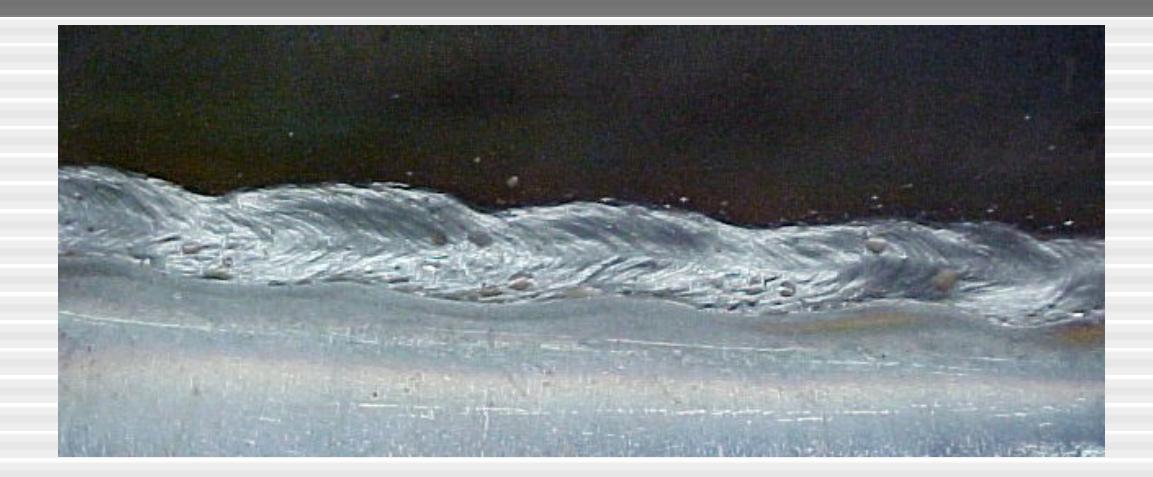
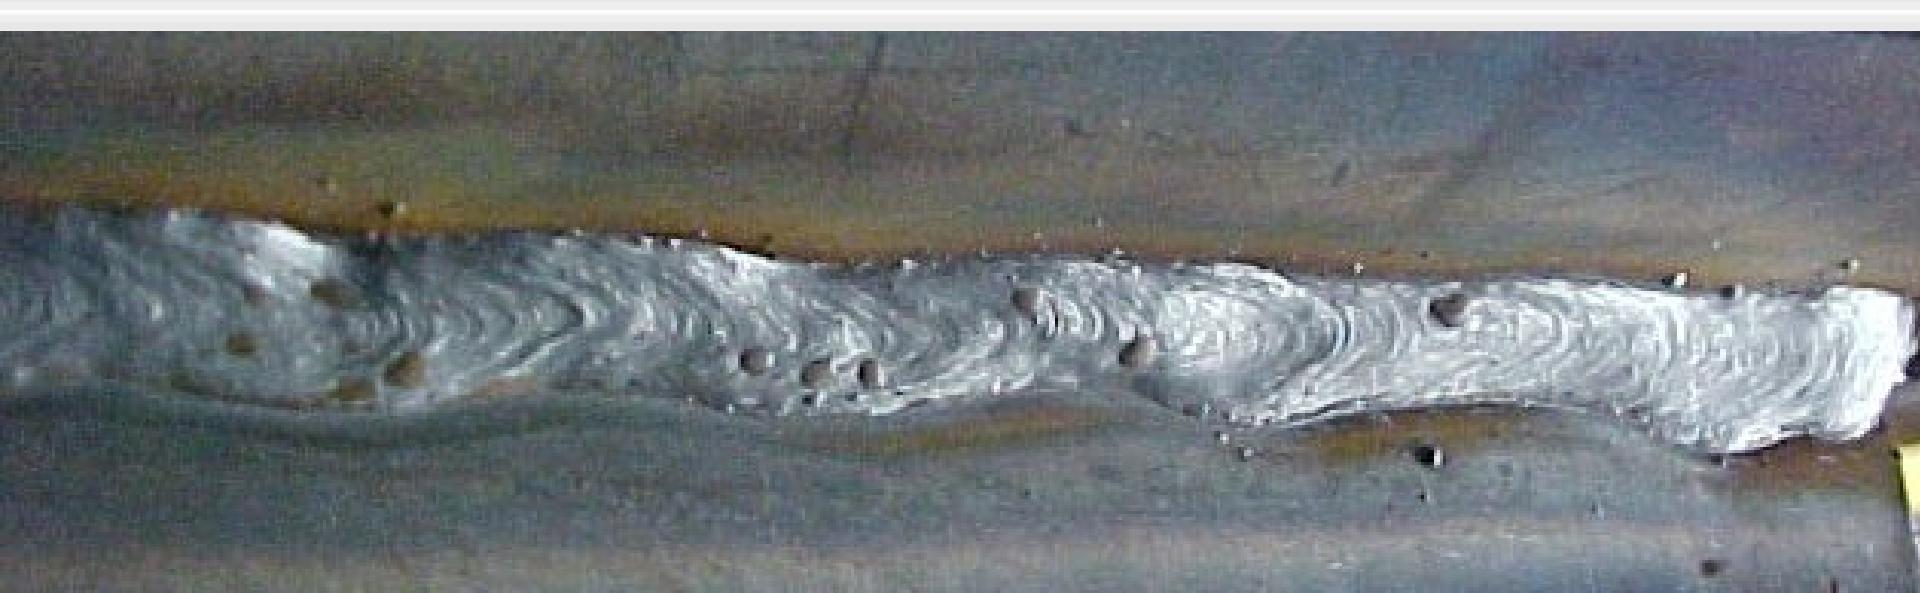
EXCESSIVE CONCAVITY

- Definition: Concavity or convexity of a fillet weld exceeding specified limits
- Cause: Amperage and travel speed
- Prevention: Observe proper parameters and techniques.
- Repair: Grind off or weld on. Must blend smoothly into the base metal.

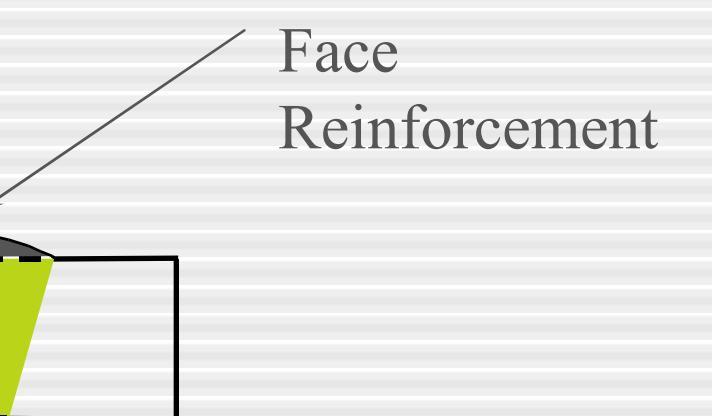
Root Reinforcement

- The amount a groove weld extends beyond the surface of the plate
 - Excessive
 - Insufficient
 - Improper contour

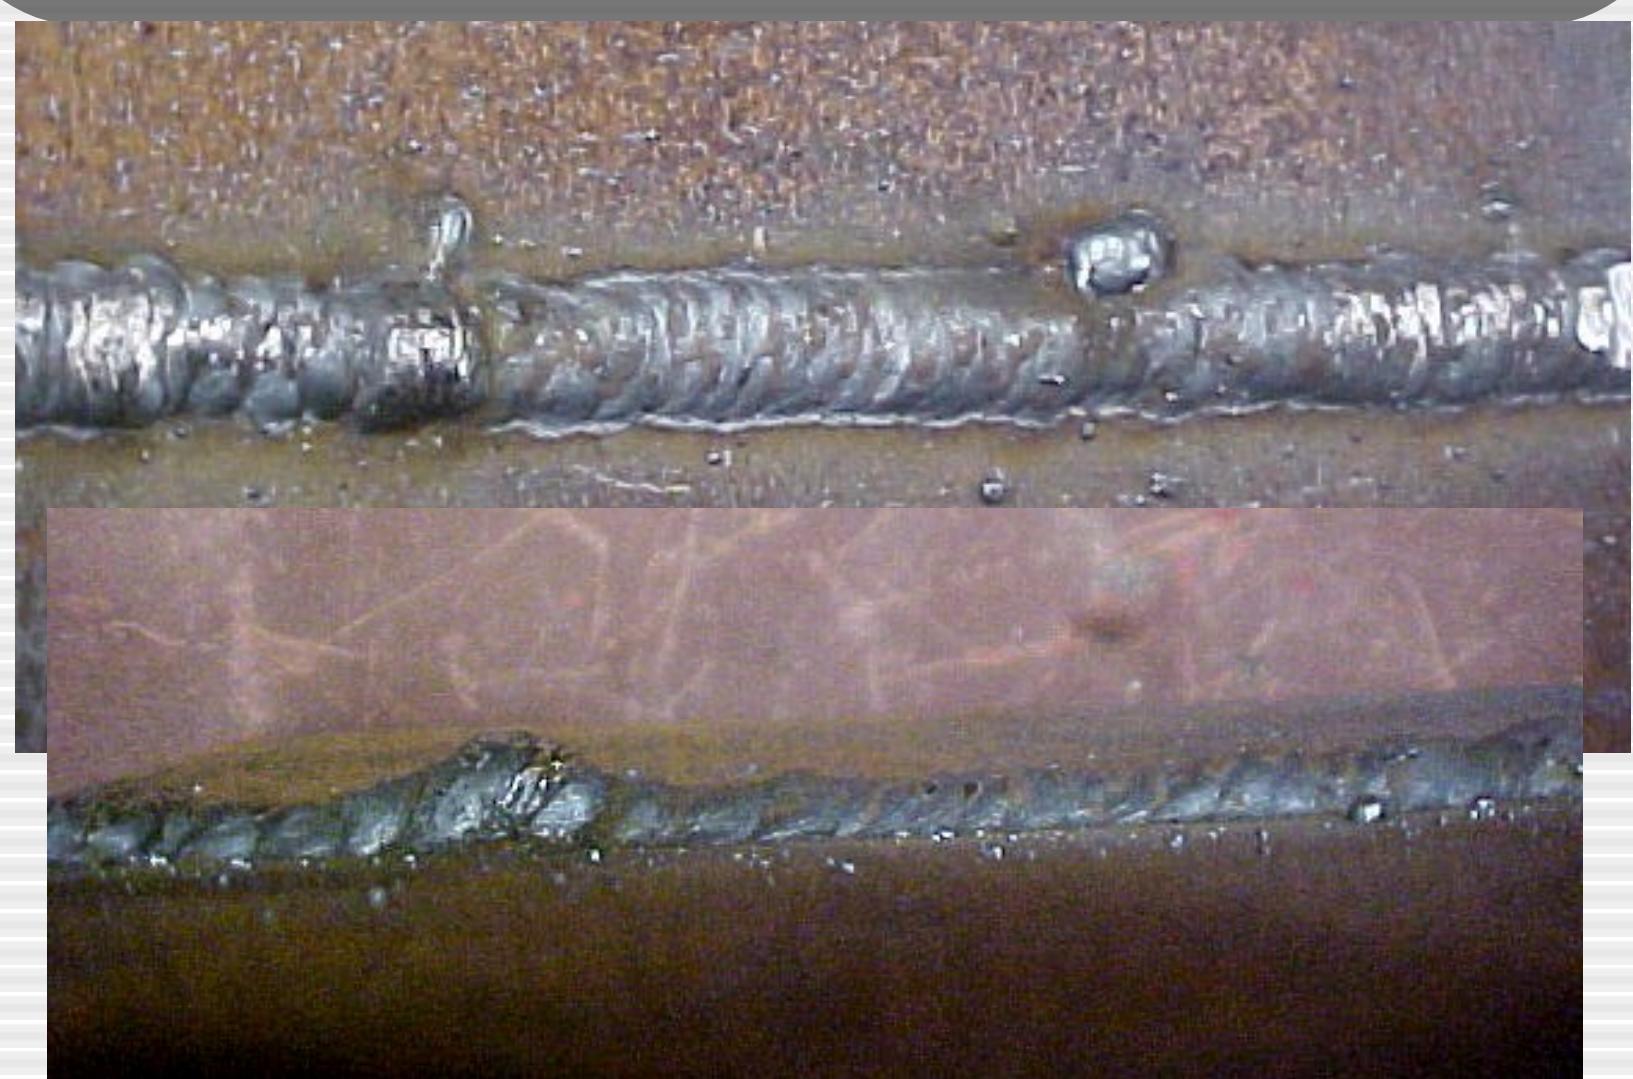
EXCESSIVE WELD REINFORCEMENT

- Definition: Specifically defined standard.
- Typically, Flush to 1/16" (pipe) or flush to 1/8" (plate or structural shapes).
- Cause: Travel speed too slow, amperage too low Prevention: Set amperage and travel speed on scrap plate.
- Repair: Remove excessive reinforcement and feather weld toes to a smooth transition to the base plate.

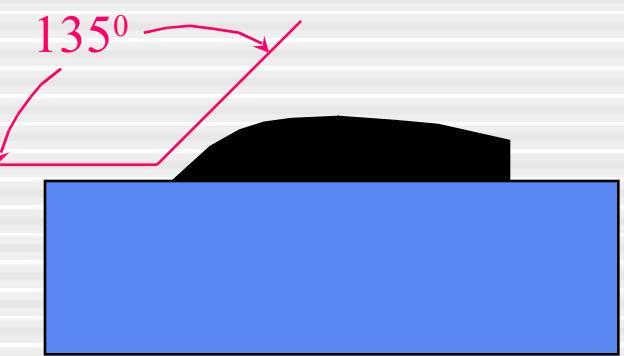
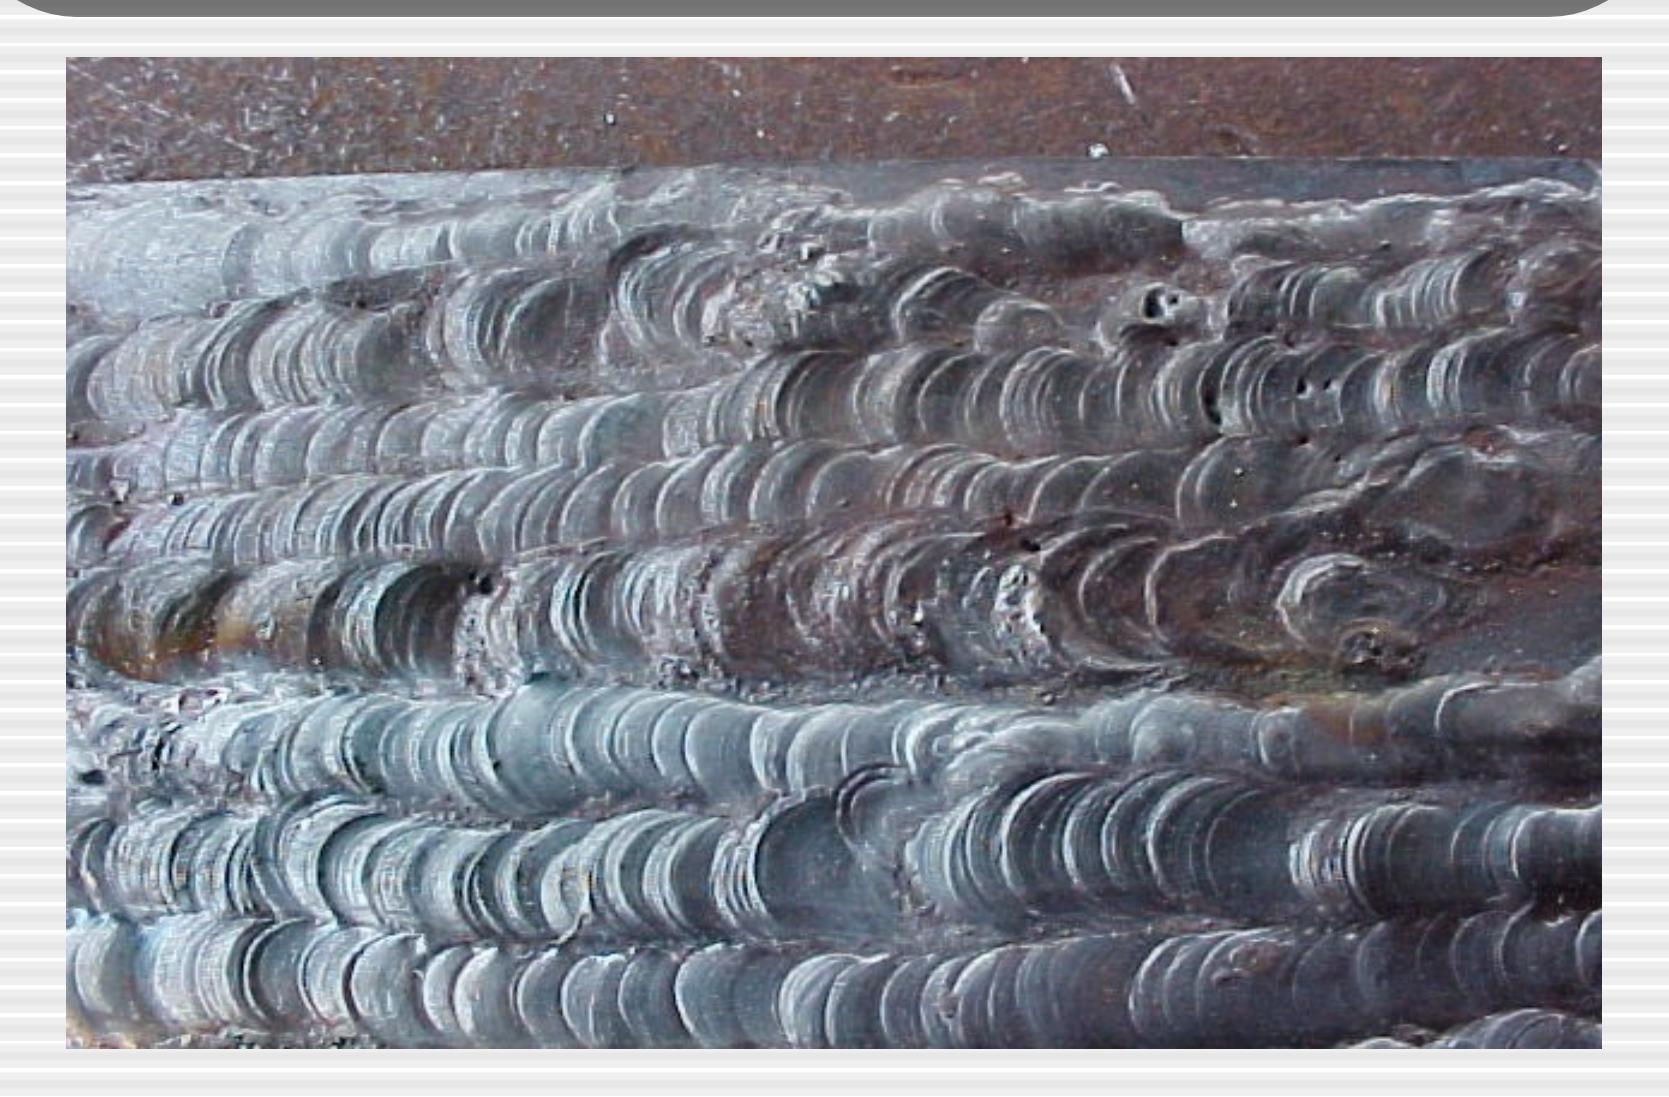
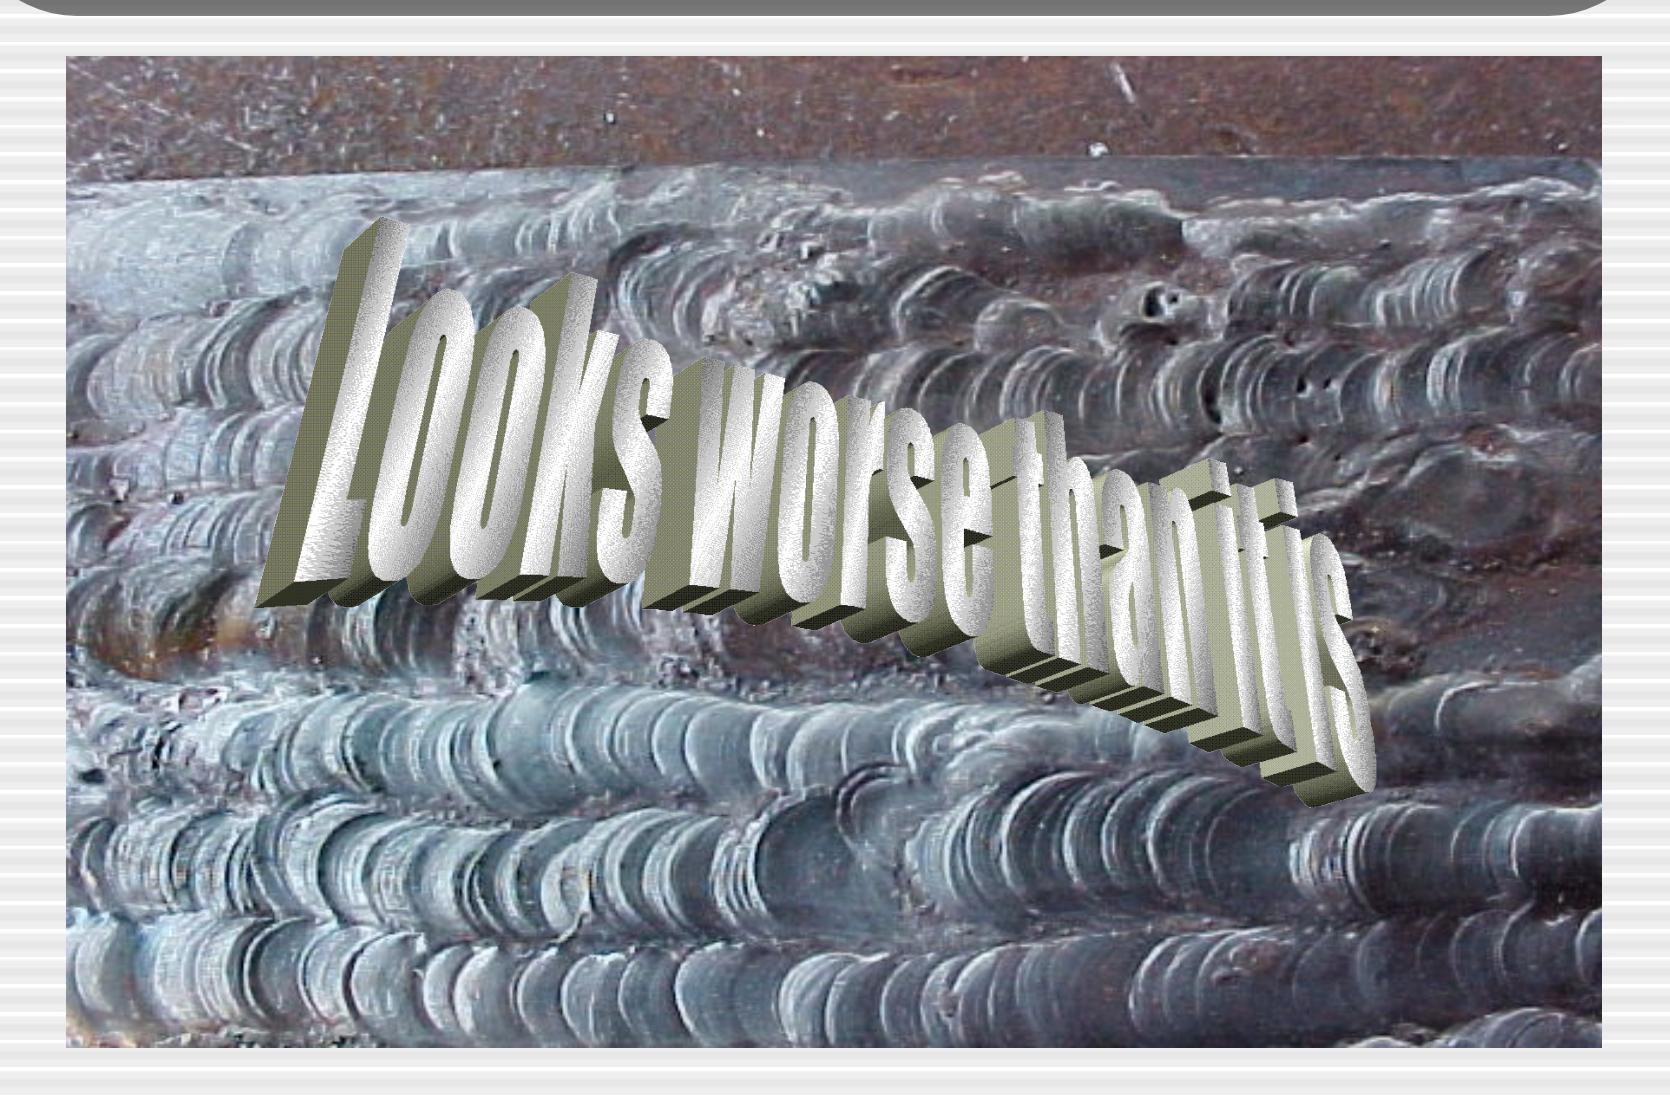
UNACCEPTABLE WELD PROFILES

- Definition: When the weld exhibits less than a 135° transition angle at the weld toe.
- Cause: Poor welding technique
- Prevention: Use proper techniques. A weave or whip motion can often eliminate the problem.
- Repair: The weld face must be feathered into the base plate.

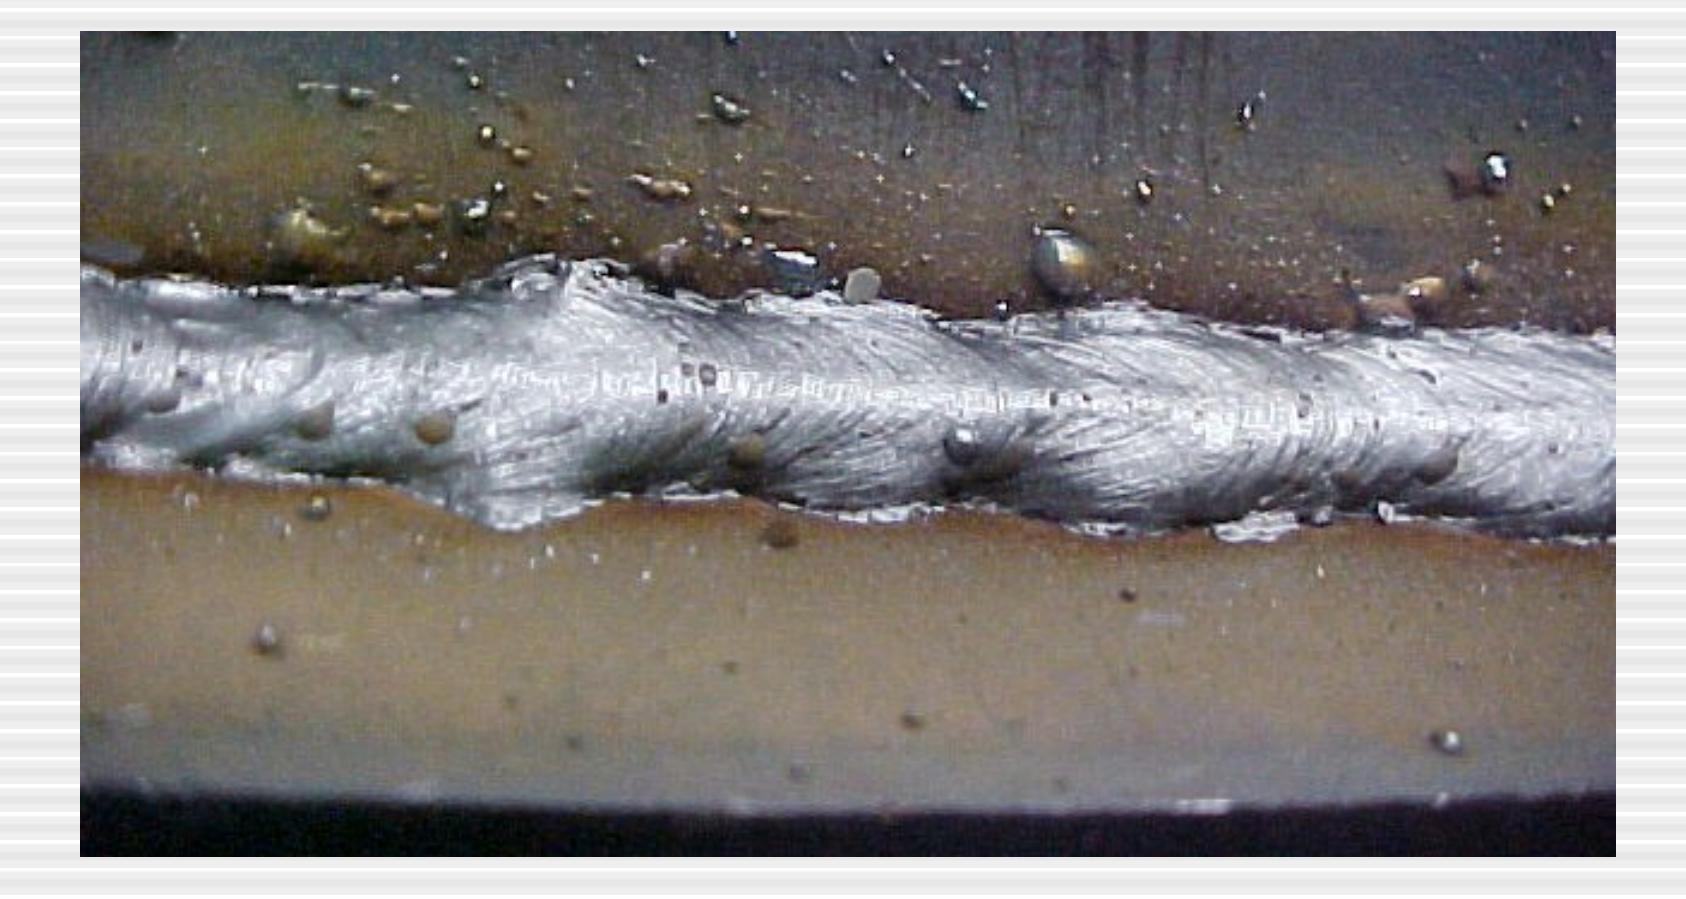
OVERLAP

- Definition: When the face of the weld extends beyond the weld toe
- Cause: Improper welding technique. Typically, electrode angles and travel speed.
- Prevention: Overlap is a contour problem. Proper welding technique will prevent this problem.
- Repair: Overlap must be removed to blend smoothly into the base metal.
 - Be careful of deep grind marks that run transverse to the load.
 - Also be careful of fusion discontinuities hidden by grinding. Use NDT to be sure.

•Overlap is measured with a square edge such as a 6" rule. No amount of overlap is typically allowed.

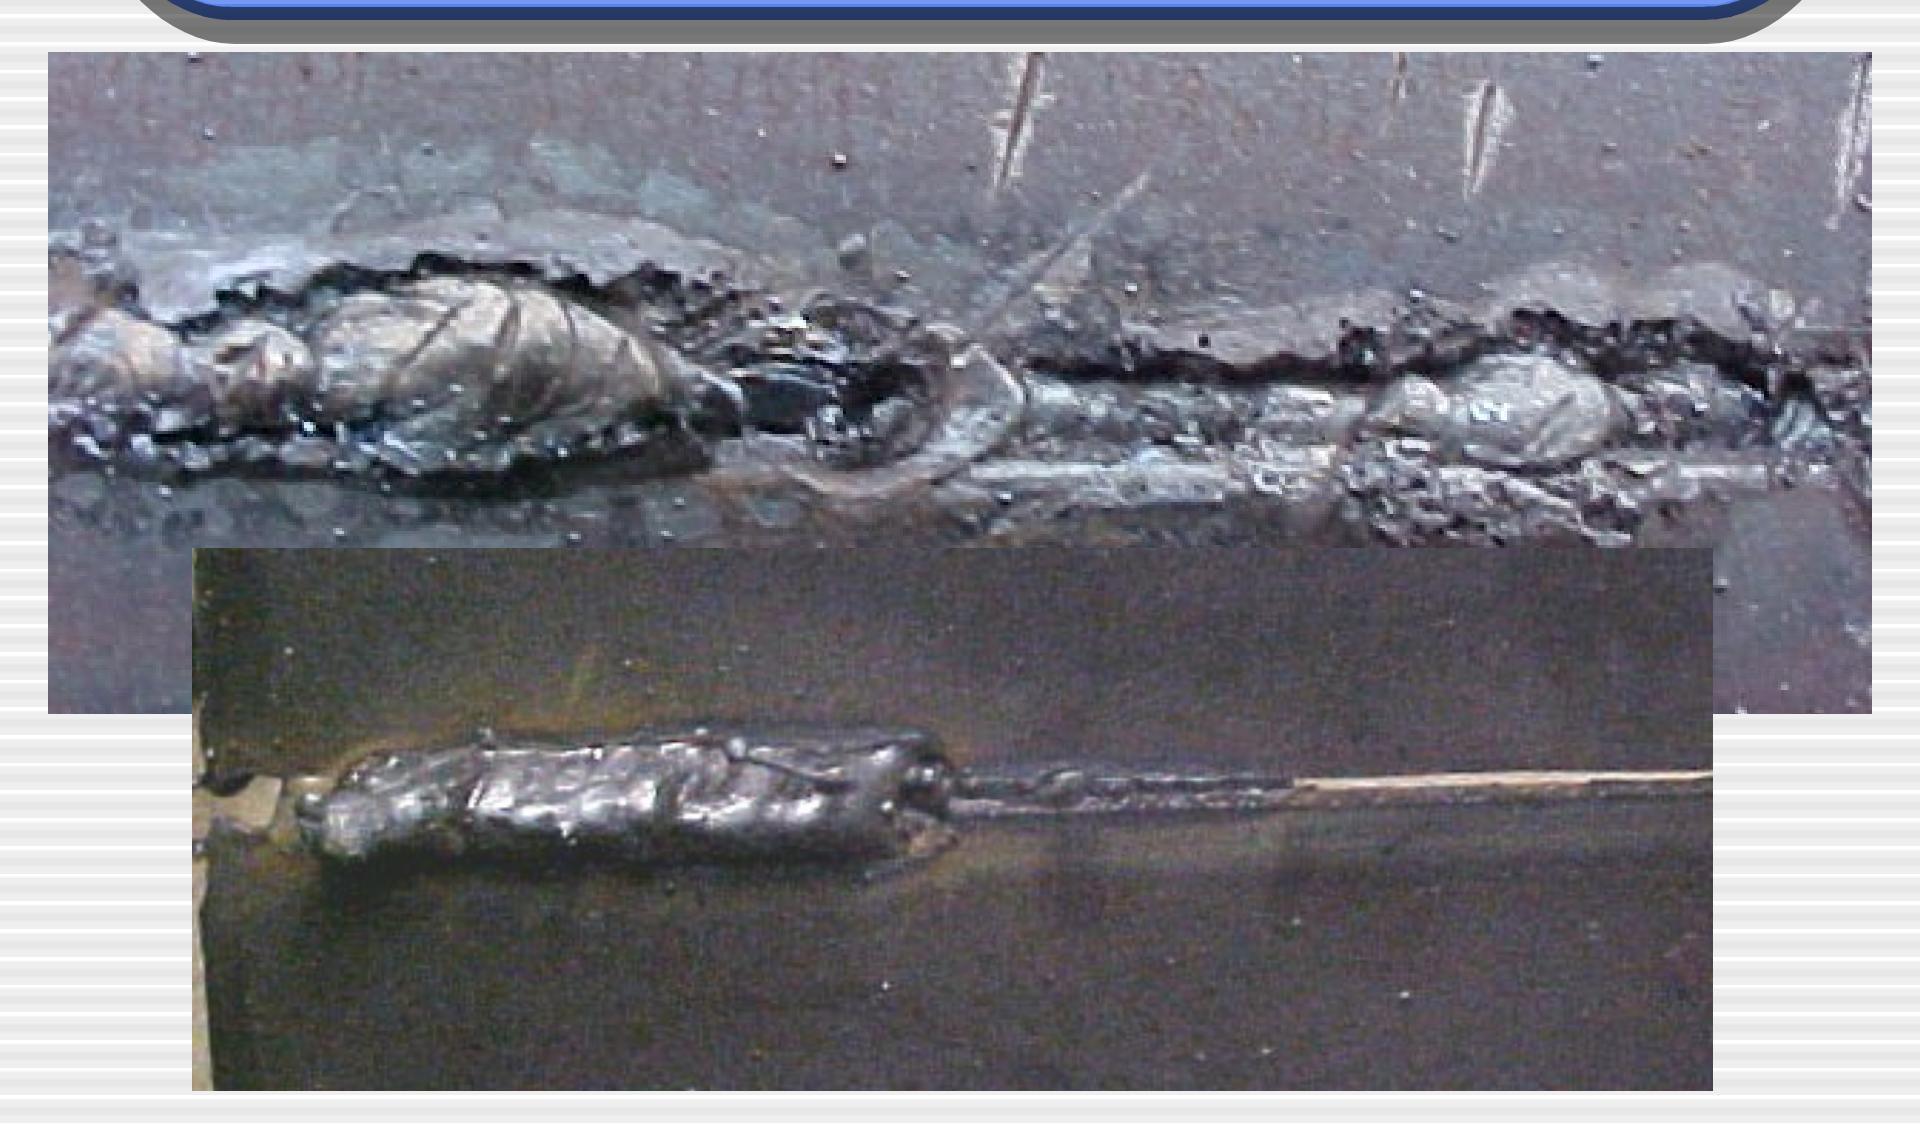
INCOMPLETE & EXCESSIVE PENETRATION

- Definition: When the weld metal does not extend to the required depth into the joint root
- Cause: Low amperage, low preheat, tight root opening, fast travel speed, short arc length.
- Prevention: Correct the contributing factor(s).
- Repair: Back gouge and back weld or remove and reweld.
